CHARNLEY-PERSKY HOUSE

CONSERVATION MANAGEMENT PLAN

The Charnley-Persky House is one of the most significant buildings in the early development of modern residential architecture in America. Designed by renowned late nineteenth century architecture firm, Adler and Sullivan, the house was completed in 1892 for Mr. and Mrs. James Charnley. Although the lack of physical evidence such as architectural drawings makes the authorship of house unclear, it is widely believed that there are design features and elements that can be attributed to both Louis Sullivan and Frank Lloyd Wright. The house, which is located in the Astor Street Historic District, was twice designated a City of Chicago Landmark in 1960 and 1972, was listed on the National Register of Historic Places in 1970, and was designated a National Historic Landmark in 1998.

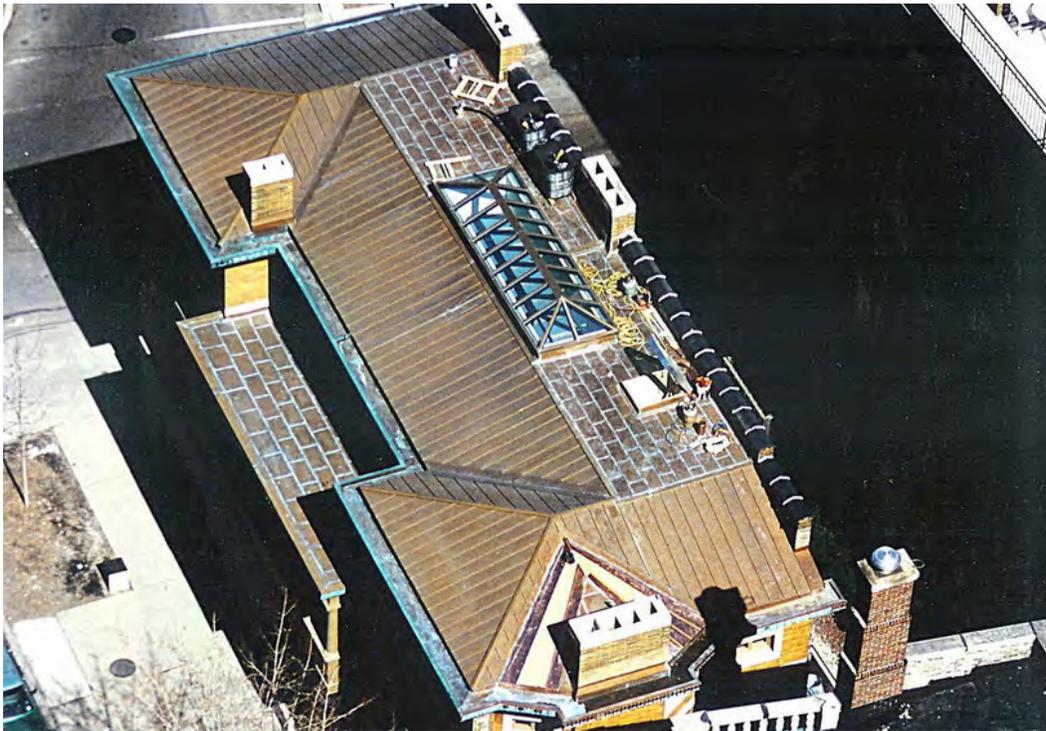
- Flat seamed copper roofing – Some of the seams appear to have opened which could lead to water leakage inside the house.
- Copper roofing – Appears to be in good condition.
- Pressed copper cornice – Is in fair condition. Some of the copper squares and circles that comprise the ornamental frieze are loose or missing. Some have become unsecured and have blown off during heavy winds.
- Parapet wall – The parapet wall appears to be in good condition. There is some staining on the roof side of the wall.

5-35
Aerial view showing Char-
nley-Persky
House roof,
SOM.

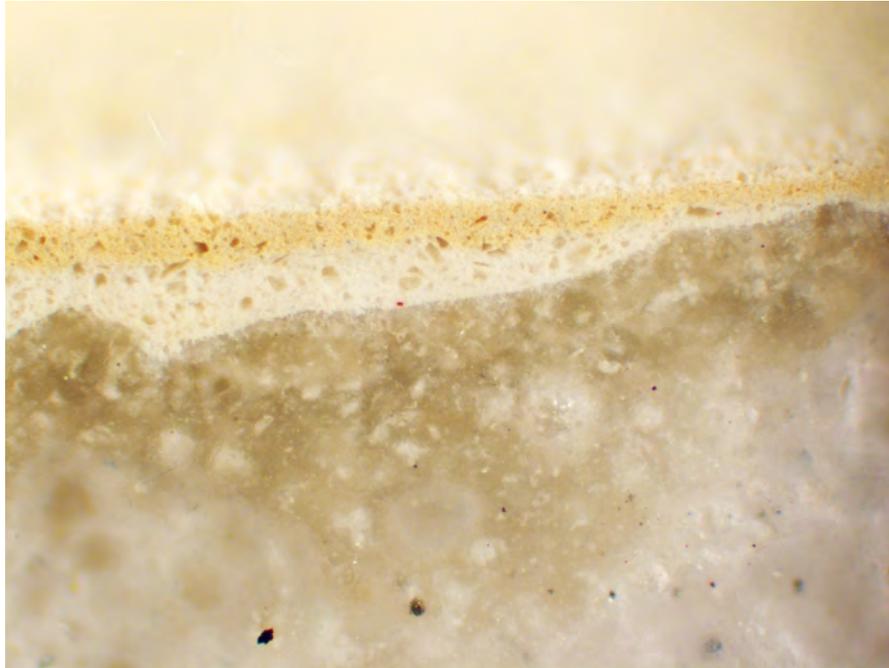
Figure 1. Sample CPH-5 (first floor hallway, 100x, visible light). This sample does not contain original material and was taken from an area where the original plaster has been replaced. The composition of the plaster substrate appears different than the other samples seen in cross-section that were taken from the archived collection and contains only two layers of modern paint.

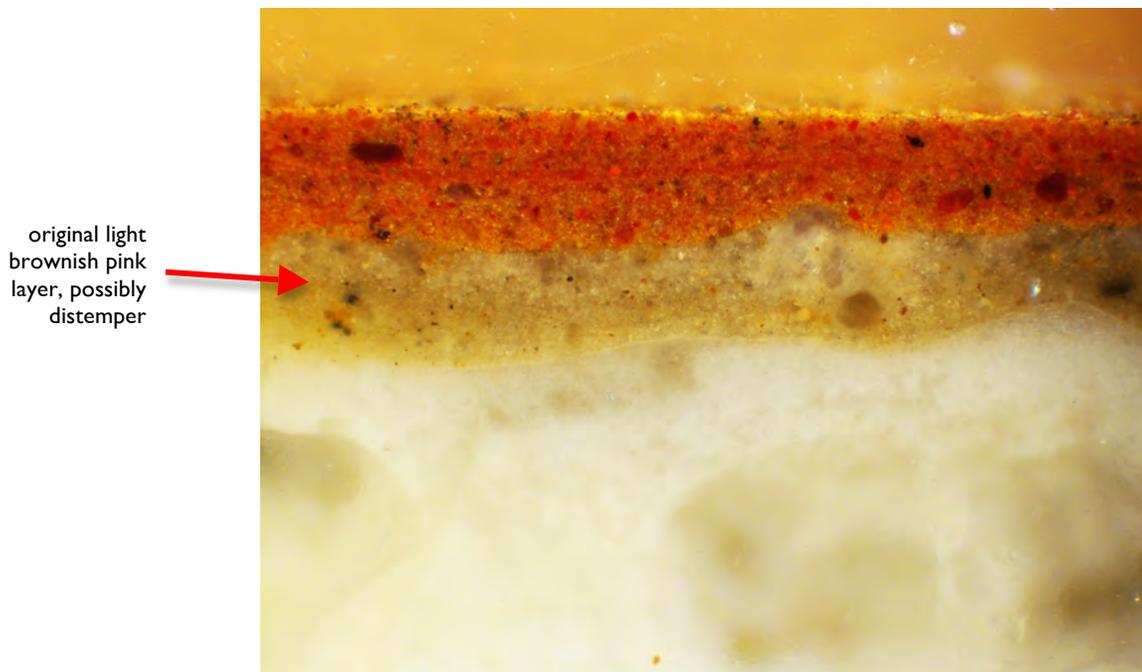
Figure 7. Sample CP-B-2-b, 1st floor hallway arch over cabinet (100x, visible light). The original translucent layer was painted directly on the finish plaster.

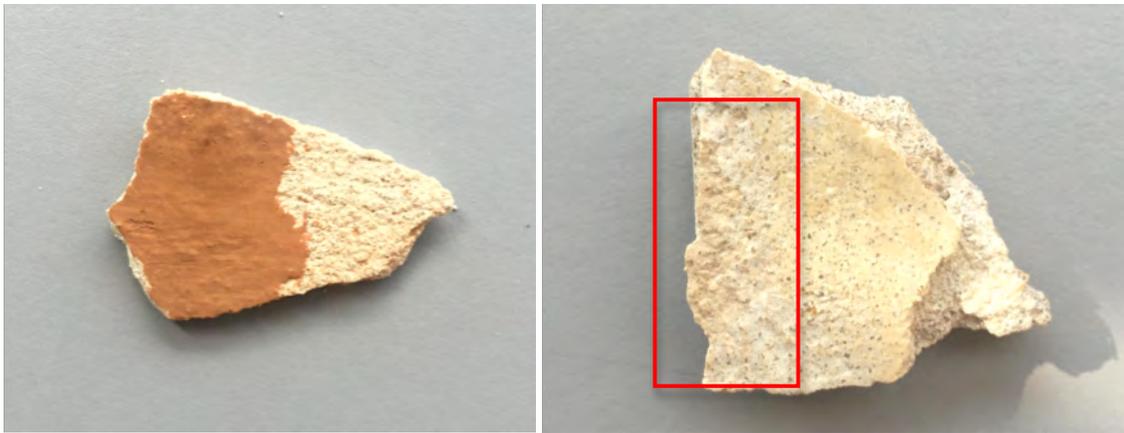
A more specific analysis of the sand float plaster textures and compositions should be conducted. If the wall and ceiling textures were in any way different depending upon location it would most likely have been an intentional design decision on the part of Frank Lloyd Wright. It was beyond the scope of this study to examine all of the relevant bulk samples in the archived collections and no ceiling samples were examined. However, except the smoother-surfaced plaster samples that came from behind a trim element, the samples that were selected in this preliminary study seem to exhibit similar textures (Figure 14).

Figure 14. Examples of the original sand float plaster texture. The sand grains are much finer than that of the plaster currently on the walls today. On the left, sample CP-B-3-c from the first floor alcove wall. On the right, sample CP-B-4h from the living room. The left portion of CP-B-4h in the red box was exposed to reveal the original light brownish pink color under a later layer of a cream-colored off-white paint that was not seen in the other analyzed cross-sections.

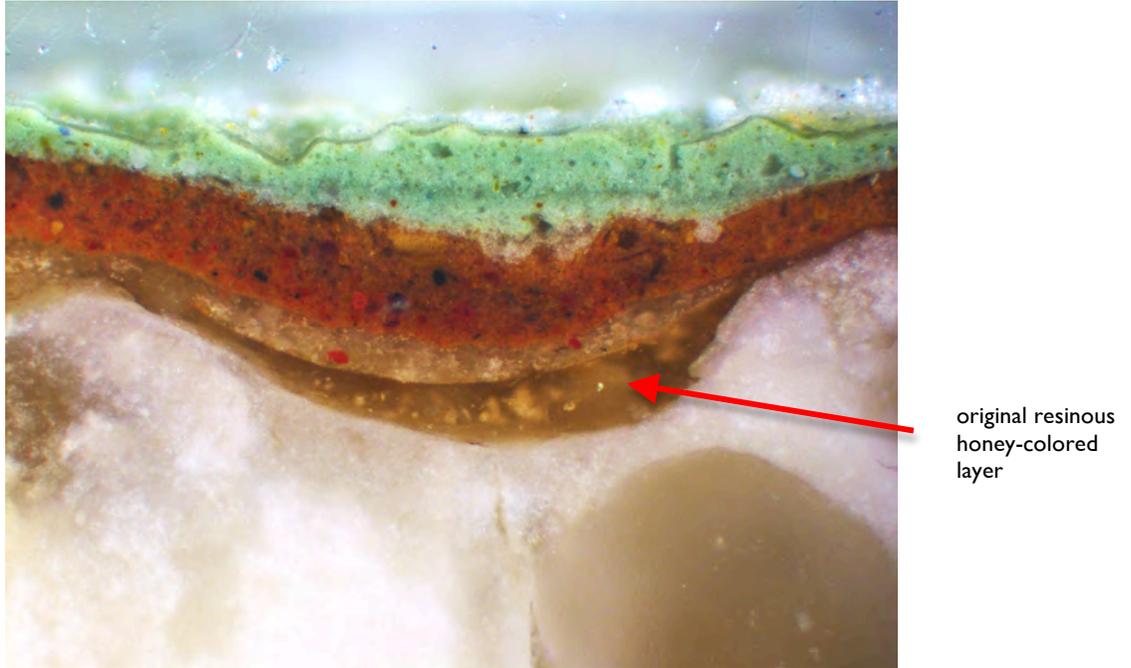
Figure 17. Sample CPH-6 (100x, visible light). The original resinous honey-colored layer is noted, applied directly to the sand float plaster finish. Overall application was thin; the resin gathered in the valleys between sand grains and barely covered the top-most protruding parts of the sand grains.

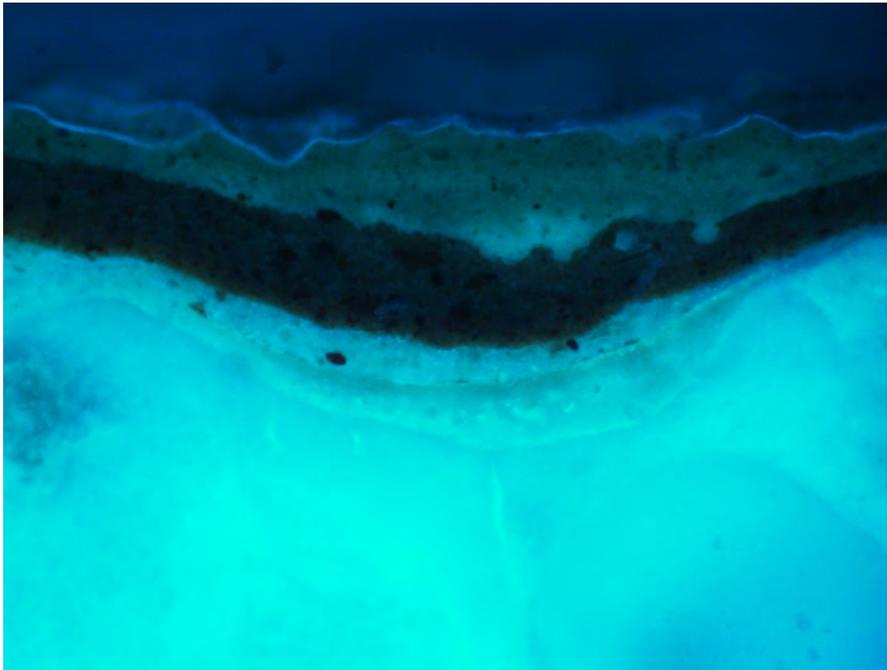
Figure 18. Sample CPH-6 (100x, ultraviolet light). UV light does not reveal any significant autofluorescing of the original resinous layer. Further instrumental analysis would need to be performed in order to fully understand the layer's chemical makeup and probable material.

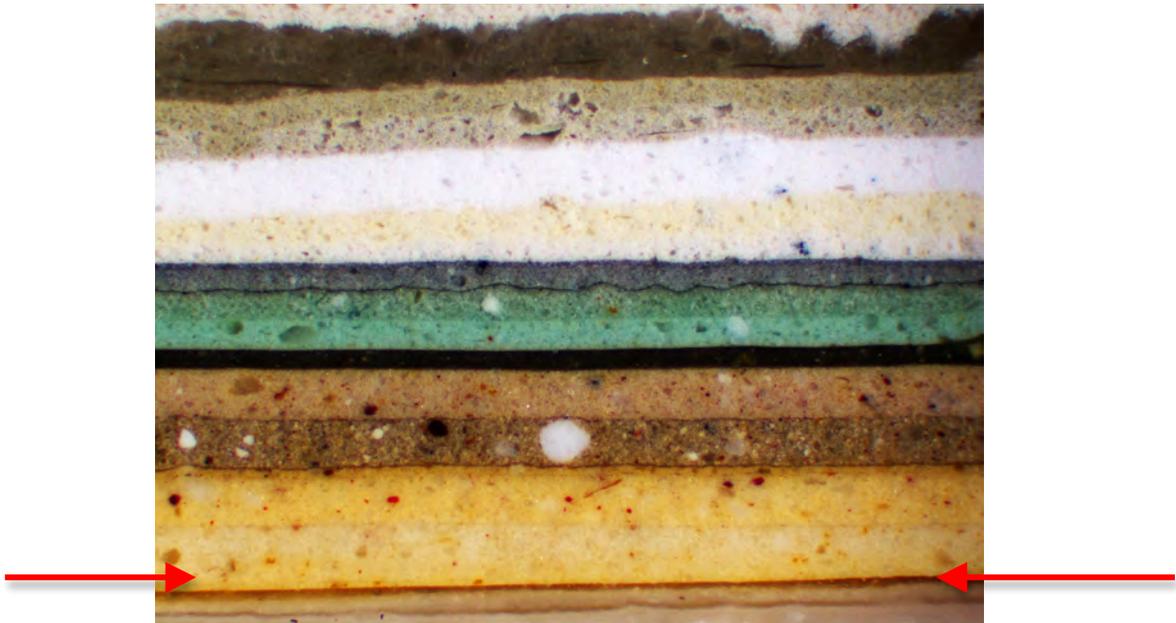
Figure 20. Sample CPH-3 (100x, visible light). The original light yellowish brown color in the first floor service stair hall is noted, as well as an original thin translucent preparation size layer. A color similar to the original paint color scheme was repeated three more times in the building's early history.

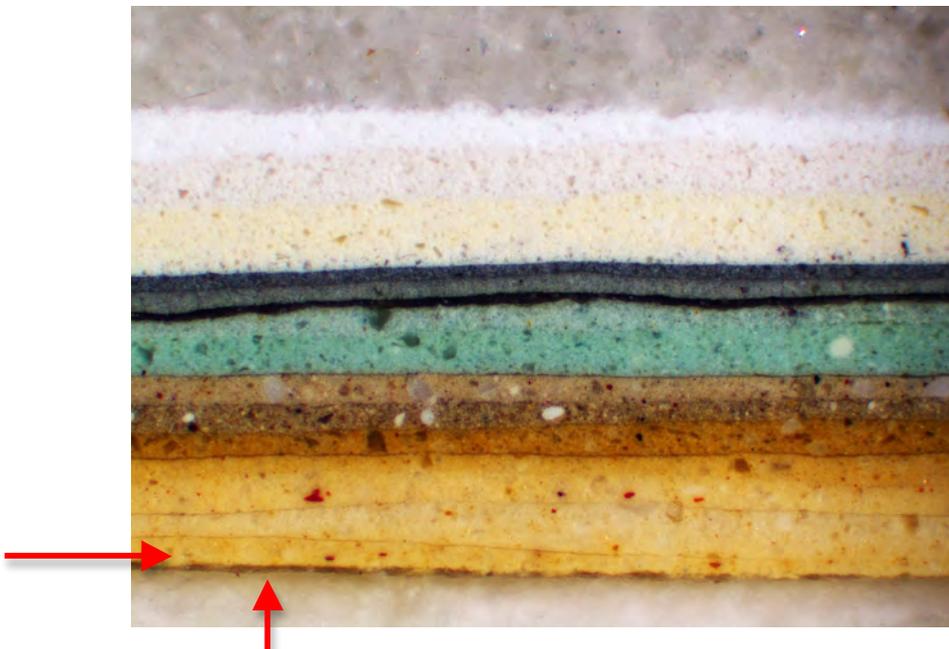
Figure 21. Sample CP-E-2 (100x, visible light). The basement service stair wall was originally treated the same as the walls on the first floor, above. While not as uniform as sample CPH-3, a thin translucent brown preparatory size layer can be seen under the paint layer and above the plaster.

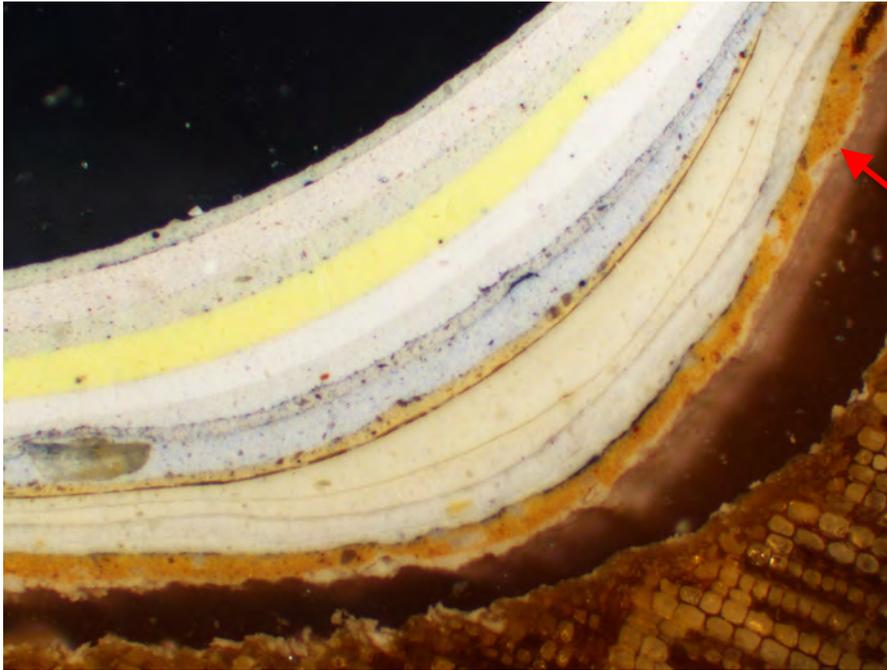
Figure 27. Sample CP-F-I-2 (50x, visible light). The original salmon pink oil-based paint and off-white primer layers are noted. Dirt layers are highly visible in this cross-section, which would make sense because it was an exterior element prone to higher levels of dirt and pollution.

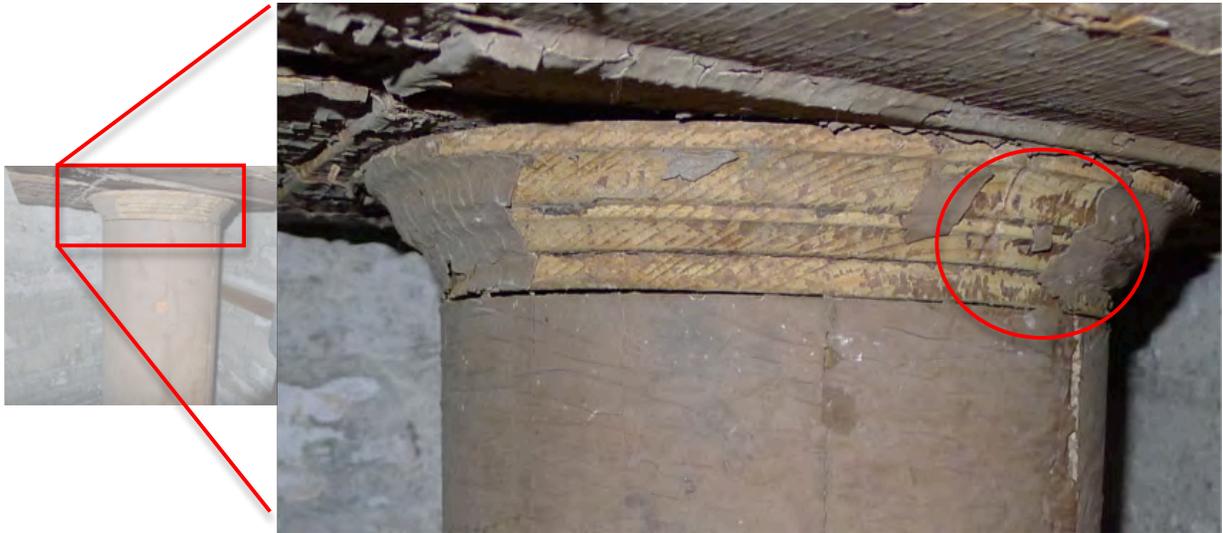
Sample CPH-4 was taken from the exterior column that is currently being stored in the basement closet. The cross-section photomicrograph shows numerous layers of earth-toned painted finishes. The original layer is thin and brown (Figure 30). An attempt to reveal the original color and finish through an exposure of the column bulk sample proved difficult because the original layer is so thin and the wood substrate was extremely soft and deteriorated. The original brown paint most likely served as a protective layer that added a richer color that would have been a slightly darker brown than the wood. The original layer could also be confirmed in the bulk sample when turned on its side to see the paint layer sequencing. Examination of the column itself confirms remnants of the original thin brown paint immediately on top of the wood substrate (Figure 29).

Figure 29. Inside the red circle, remnants of a thin brown layer can be observed immediately on top of the wood substrate on the balcony column. This evidence corroborates with the cross-section layering sequencing as well as the bulk sample exposure observations in the laboratory of corresponding sample CPH-4.

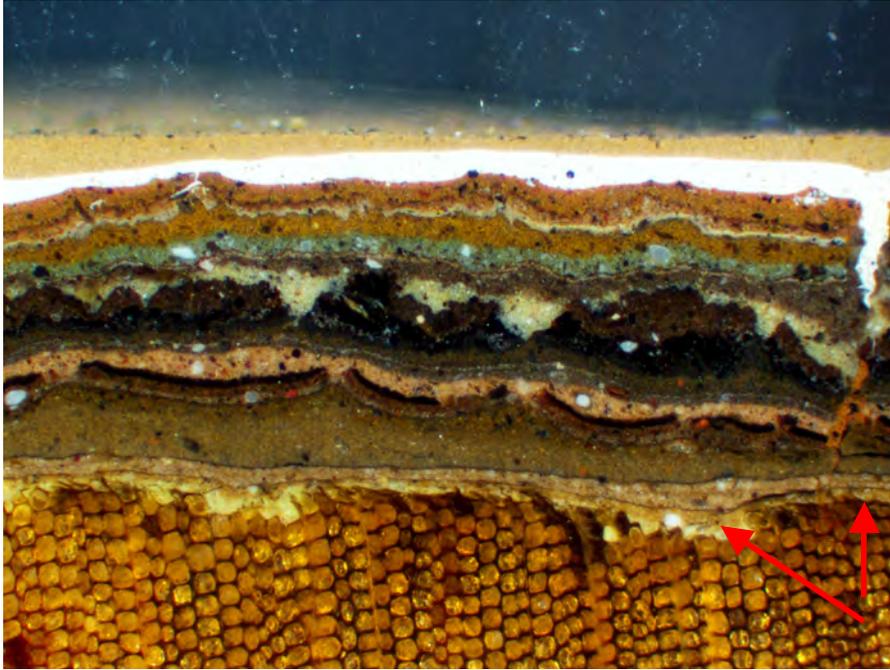
Figure 30. Sample CPH-4 (50x, visible light). The original layer is a thin, light brown.

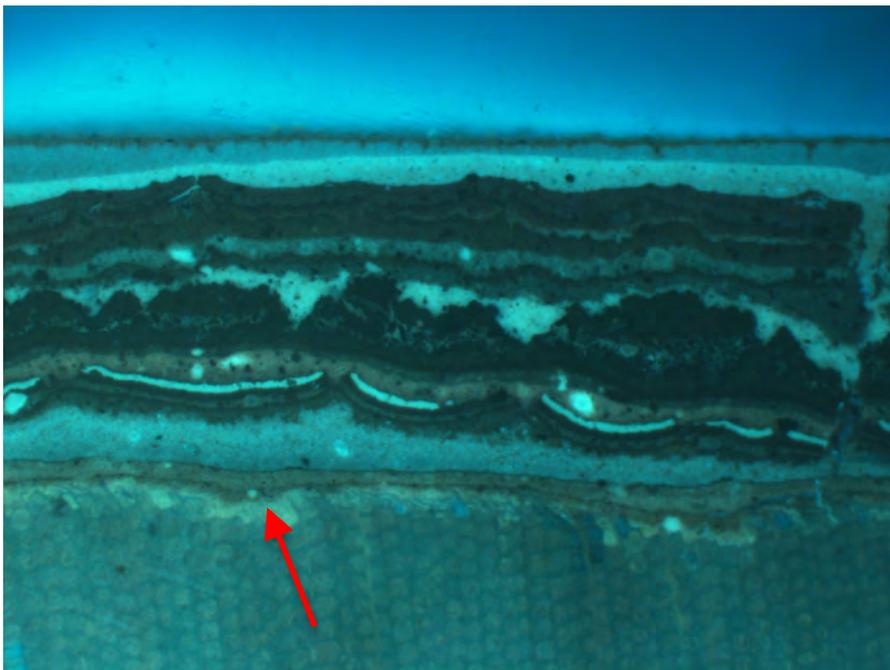
Figure 31. Sample CPH-4 (50x, ultraviolet light). The bottom-most portion of the original paint layer exhibits a slight auto-fluorescence. It could simply be the oils from the original paint layer but further instrumental analysis would have to be conducted in order to fully understand the material makeup of that layer. The wood substrate below this layer was unusually soft and deteriorated upon sample manipulation in the laboratory by scalpel during attempts at exposure to reveal the original layer.

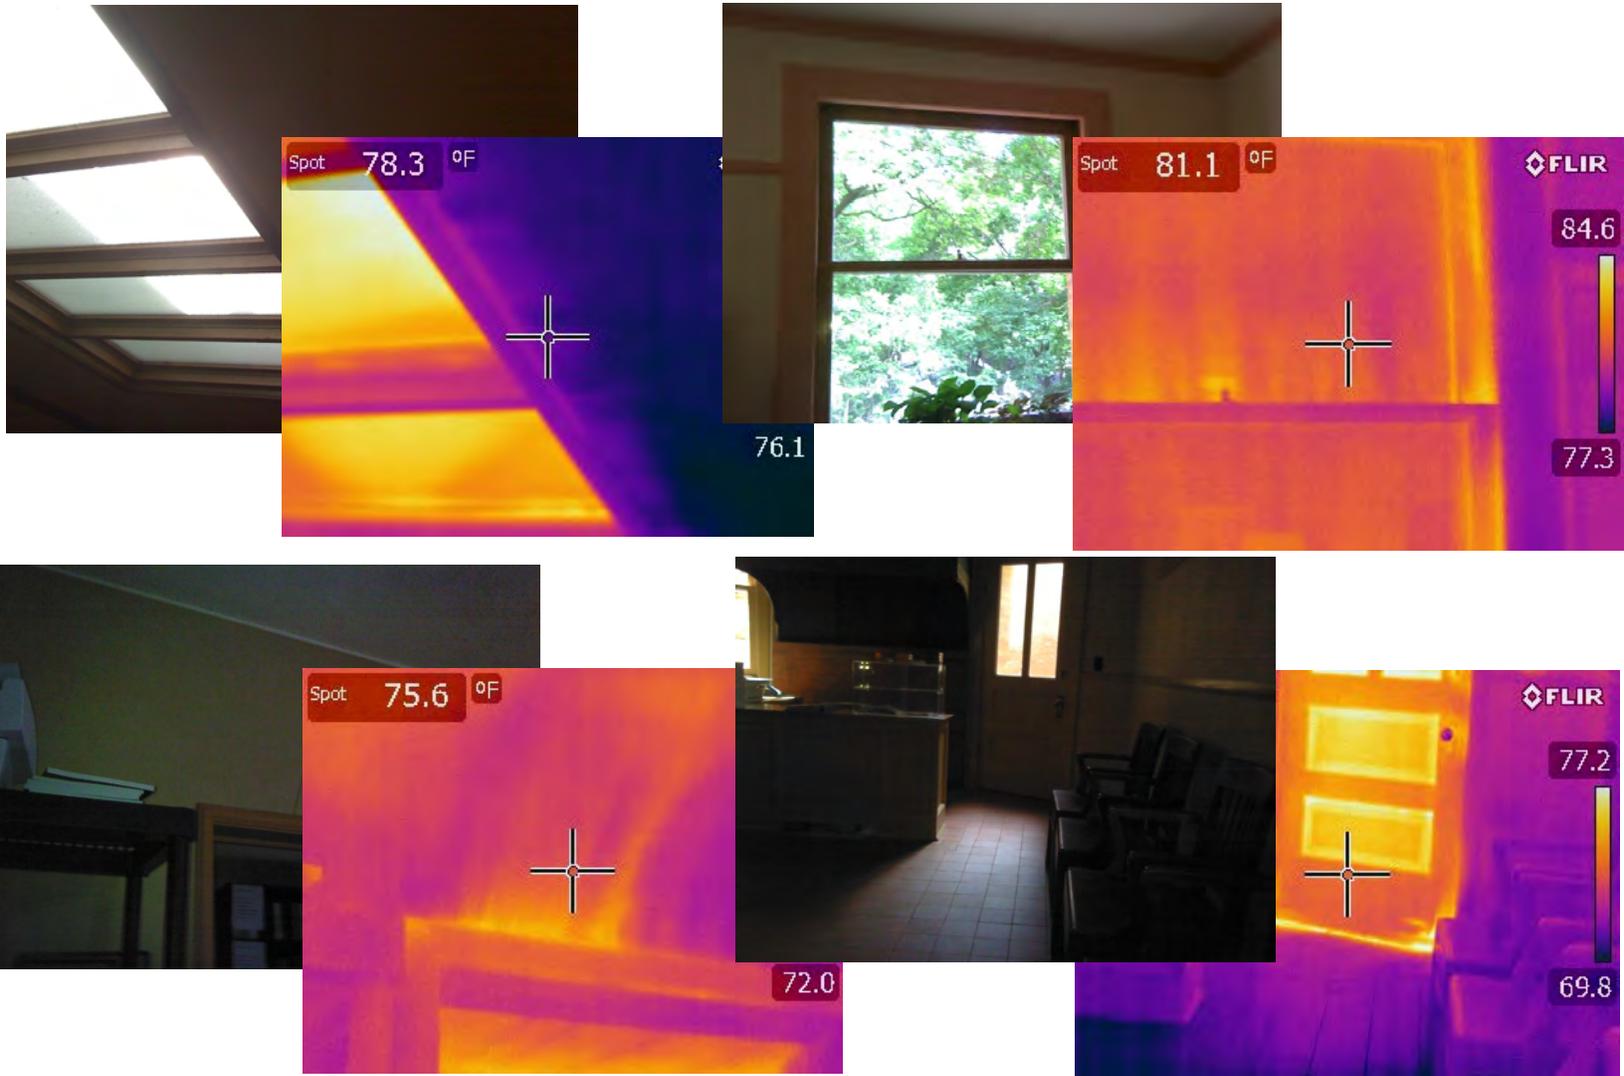
We have determined that the building envelope has minimal leakage and is built to a leakage rate just above today's standards. This being said there were some areas in the building envelope mainly the attic that were found to have some defect. These pictures show areas of infiltration during the blower door test

1. To improve efficiency, comfort and indoor air quality lost due to duct leakage we recommend Aeroseal. Aeroseal sealant will get injected into the duct system and seal all leaks 5/8" and smaller. Efficiency and comfort will be gained by sealing leaks in supply duct allowing more air to reach intended areas and dust will be reduced from sealing return duct stopping them from pulling dust from attics and floor and wall cavities.
2. Seal air leakage into attic by foaming top of all partitions, electrical boxes, duct boots and any soffit. After air-sealing is complete install R-49 of blown cellulose.

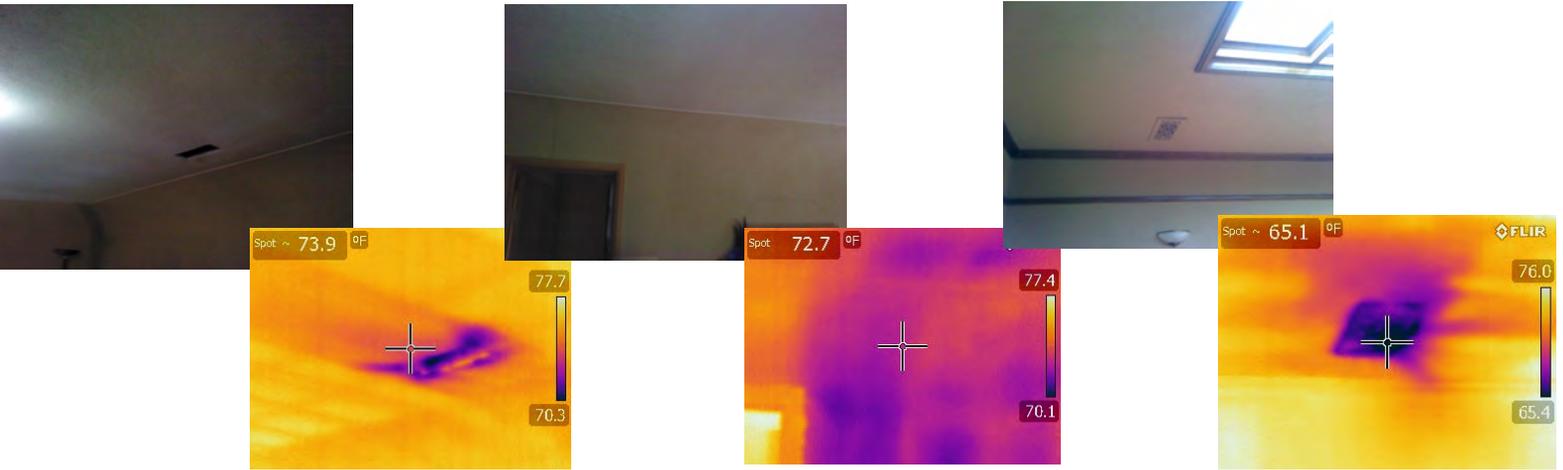
We also found evidence of the air ducts leaking into the building attic and cavities. Excessive duct leakage can severely impact the performance of the buildings HVAC systems. Duct leakage can result in a loss of total system capacity; and potentially causing heating, cooling, humidity and dust issues. These pictures show evidence of cold air leaking into wall cavities where ducts are located and warm attic air entering through registers.

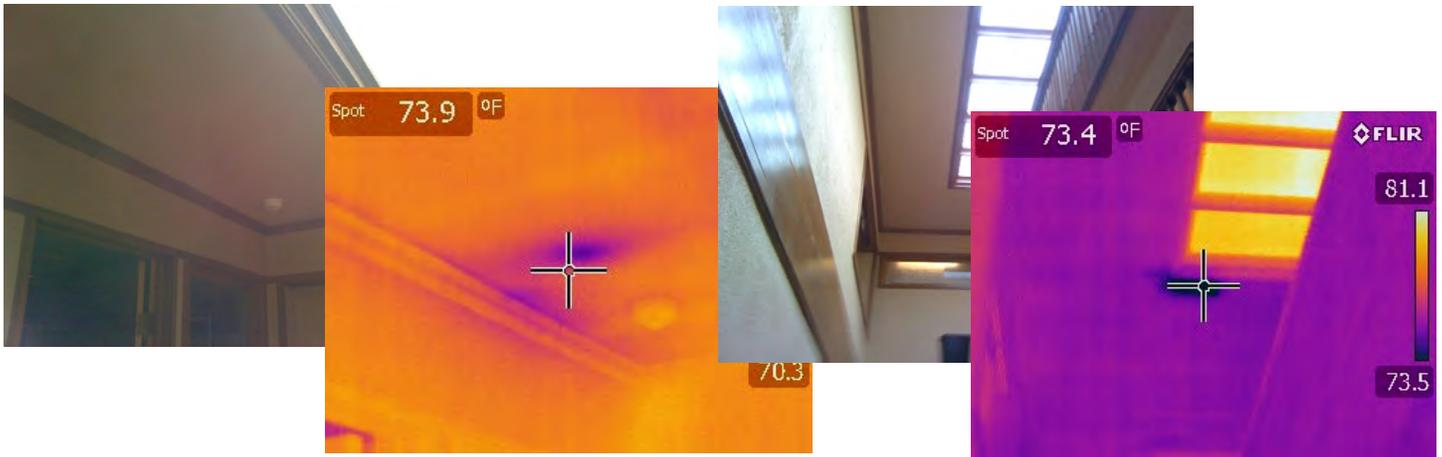
In addition to air leakage we also found evidence of water leakage in the top floor ceiling. . These pictures show evidence of cold water spots into the top floor ceiling.
