CHARNLEY-PERSKY HOUSE

CONSERVATION MANAGEMENT PLAN

The Charnley-Persky House is one of the most significant buildings in the early development of modern residential architecture in America. Designed by renowned late nineteenth century architecture firm, Adler and Sullivan, the house was completed in 1892 for Mr. and Mrs. James Charnley. Although the lack of physical evidence such as architectural drawings makes the authorship of house unclear, it is widely believed that there are design features and elements that can be attributed to both Louis Sullivan and Frank Lloyd Wright. The house, which is located in the Astor Street Historic District, was twice designated a City of Chicago Landmark in 1960 and 1972, was listed on the National Register of Historic Places in 1970, and was designated a National Historic Landmark in 1998.

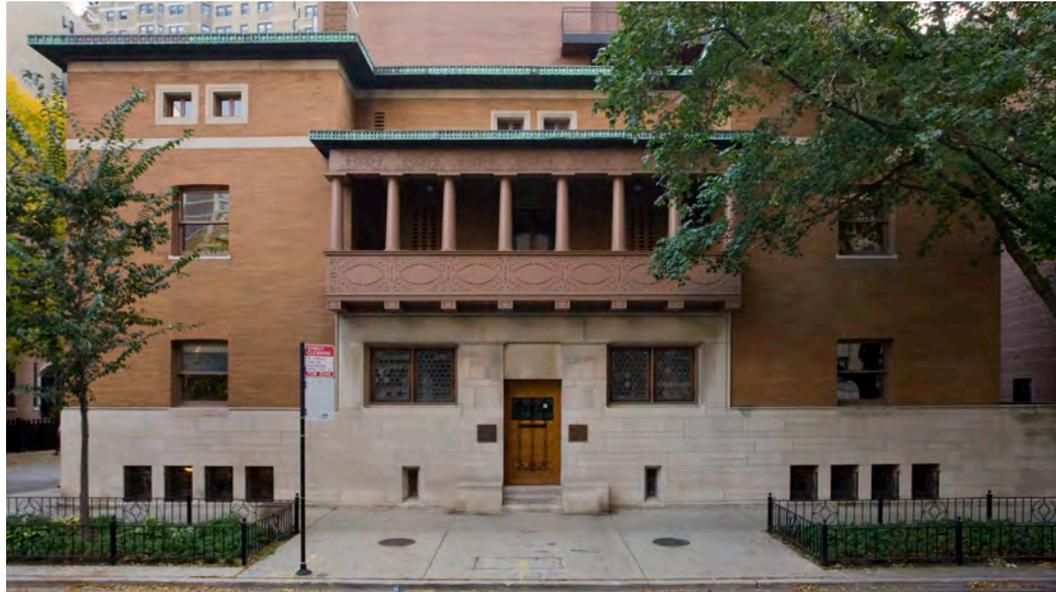
5-1
West facade,
2016, Leslie
Schwartz.

Overall the west façade is in good condition. The following conditions were observed during a visual inspection of the facade:

- Limestone – There are some small cracks in the limestone, as well as locations of previous patches and repairs that do not match. The surface of the limestone is also weathered, especially at the stone steps that lead to the front door. The limestone is soiled and stained in several locations, especially at the northwest corner where dogs urinate on the wall. The limestone was sand blasted in the 1970s and in many areas the fine horizontal lines dressing the stone have eroded away. Also, in many locations the sand blasting uncovered fossils embedded in the limestone. The limestone cap on the west courtyard wall is brittle and deteriorating.

- Brick – Some areas of staining and soiling were observed. When the limestone was sand blasted in the 1970s, some of the bricks adjacent to the limestone blocks were damaged.

- Balcony – The wood balcony, which was rebuilt in the 1970s, is in fair condition. Repairs are made annually to close cracks and re-glue the wood that is delaminating due to water infiltration.

- Doors – The oak front door, which is an exact replica of the original door, is in good condition with only small nicks and scuffs. The finish is also slightly worn on both the wood and bronze hardware. The decorative wrought iron grillwork is in good condition but must be painted regularly to prevent corrosion. The replacement door to the courtyard is in good condition; however, due to exposure to weather from both sides the frame is tight causing the door to stick and be difficult to open and close.

- Windows – The leaded glass windows flanking the entry are original. The other windows were restored and retrofitted with new glazing during the 1980s SOM renovation. The second and third floor windows, which had been replaced in the 1920s, were restored to their original configuration and appearance. The windows appear to be in good condition. The finish is worn on the iron grills over the basement windows and there is some minor corrosion. The expansion of the wrought iron grills has caused limestone in the window surround to spall off in several places. The coming on the leaded glass windows is in poor condition.

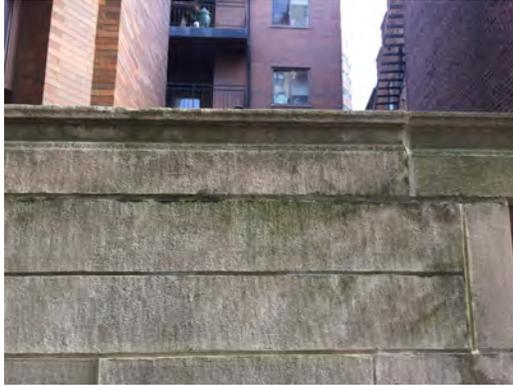
5-2

Left: Organic growth on stone wall, 2016, Harboe Architects.

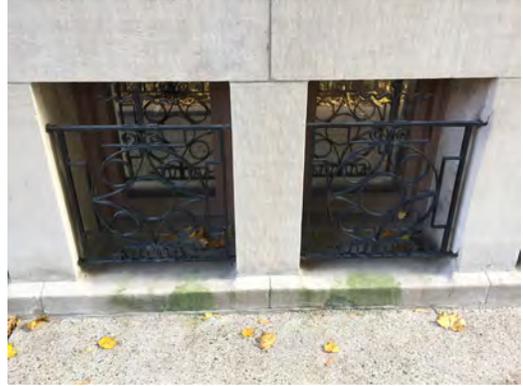
5-3

Right: Staining under basement windows, 2016, Harboe Architects.

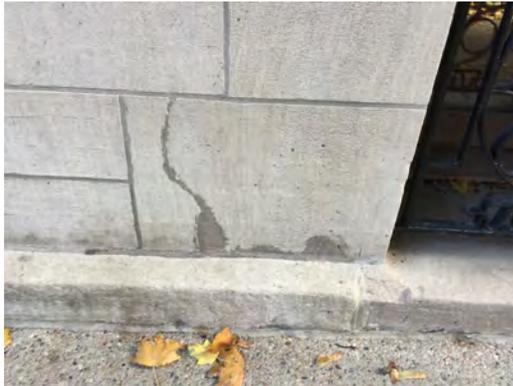
5-4

Left: Previously patched crack in stone wall, 2016, Harboe Architects.

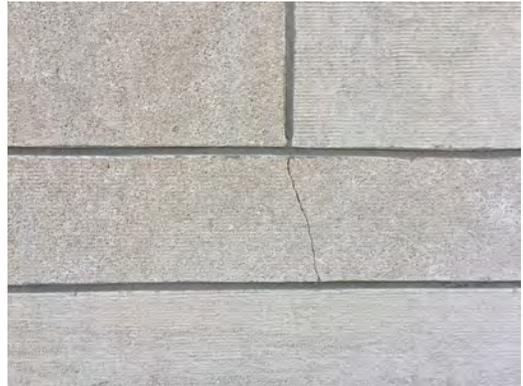
5-5

Right: Crack in stone, 2016, Harboe Architects.

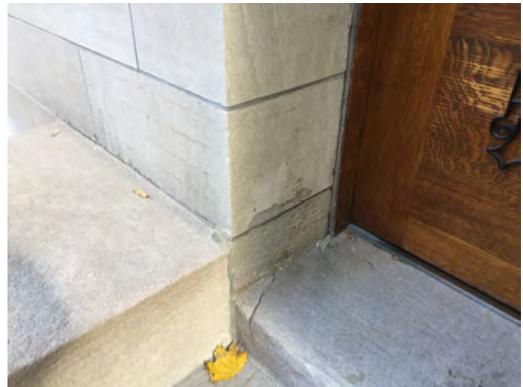
5-7

Right: Crack in stone step, 2016, Harboe Architects.

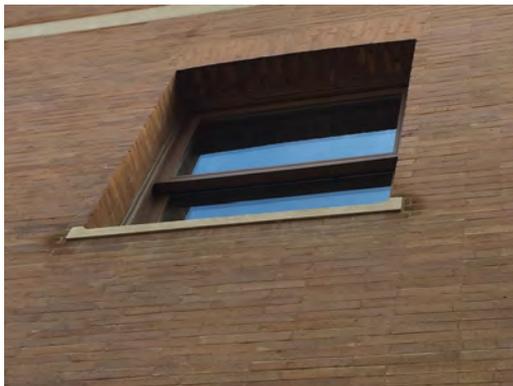
5-8

Left: Soiled brick under window sill, 2016, Harboe Architects.

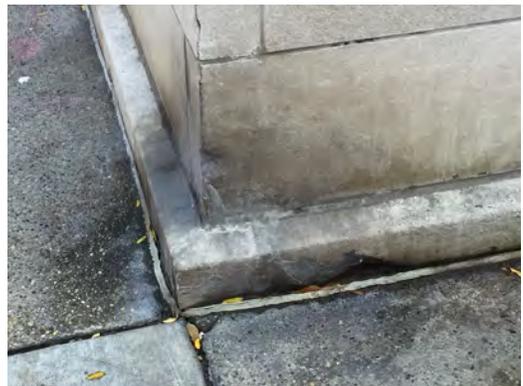
5-9

Right: Soiled stone base at northwest corner, 2016, Harboe Architects.

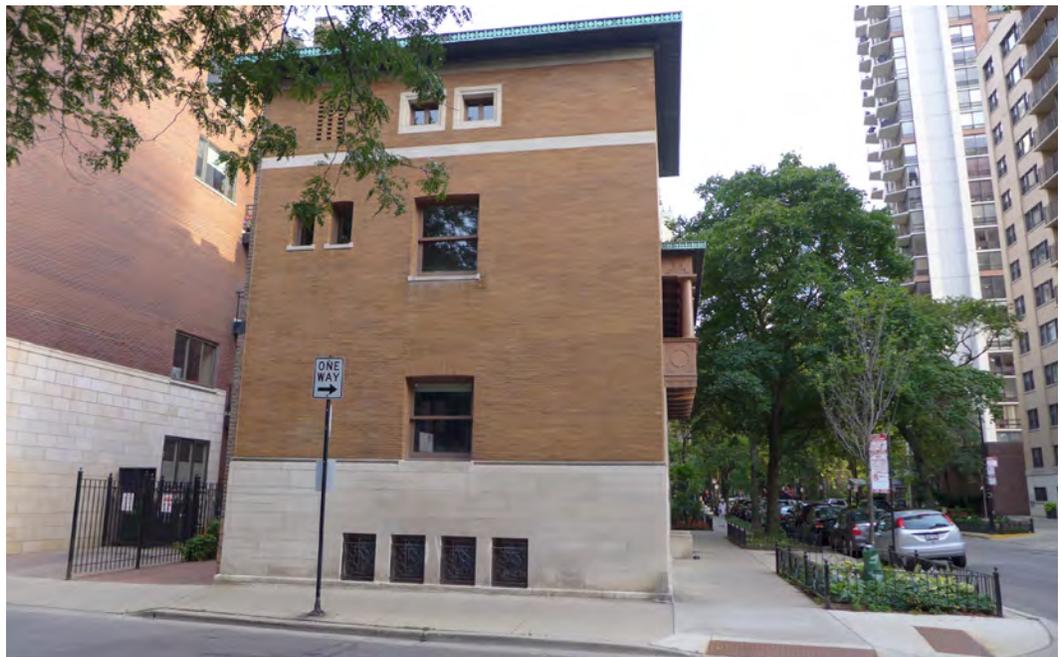
5-12

Overall the north façade is in good condition. The following conditions were observed during a visual inspection of the facade:

- Limestone – There are some small cracks in the limestone, as well as locations of previous patches and repairs that do not match. The surface of the limestone is also worn from previous sandblasting and soiled in several locations.

- Brick – The brick appears to be in good condition with some areas of staining and soiling observed. There is some damage at areas near the limestone from previous sandblasting.

- Windows – The other windows were restored and retrofitted with new glazing during the 1980s SOM renovation. The second and third floor windows, which had been replaced in the 1920s, were restored to their original configuration and appearance. The windows appear to be in good condition. The finish is worn on the iron grills over the basement windows and there is some minor corrosion. The expansion of the wrought iron grills has caused some limestone in the window surrounds to spall.

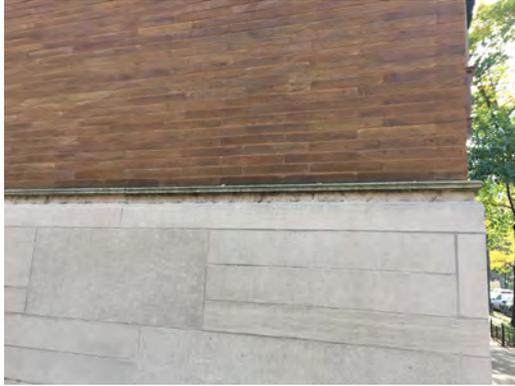
5-13

Left: Soiled stone string-course, 2016, Harboe Architects.

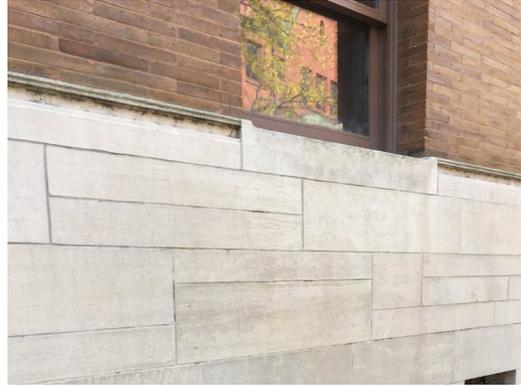
5-14

Right: Soiled stone string-course and window sill, 2016, Harboe Architects.

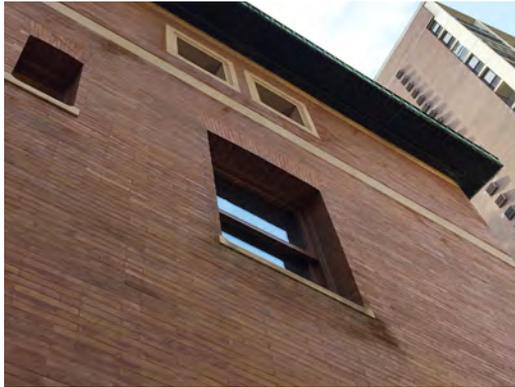
5-15

Left: Staining on brick under window sill, 2016, Harboe Architects.

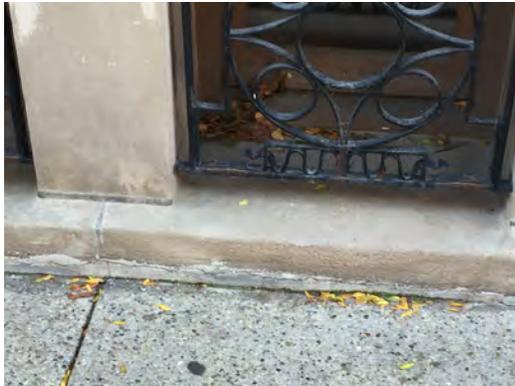
5-17

Left: Corrosion on iron grill, 2016, Harboe Architects.

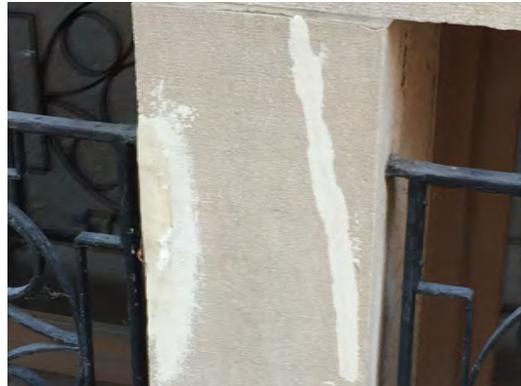
5-18

Right: Non-matching stone patches, 2016, Harboe Architects.

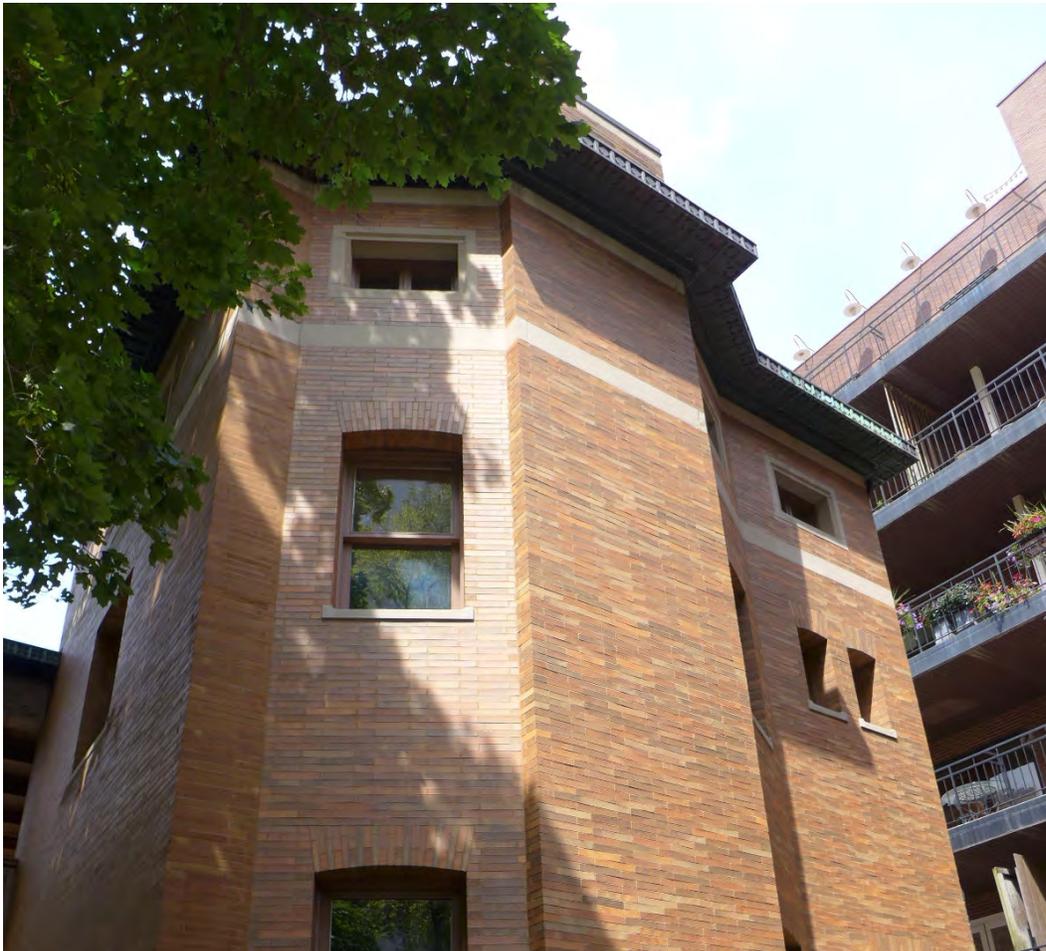
5-19

Overall the south façade is in good condition. Because the south facade was completely rebuilt in the SOM restoration, many of the materials and elements are only approximately thirty years old. The following conditions were observed during a visual inspection of the facade:

- Limestone – There are some small cracks in the limestone, as well as locations of previous patches, repairs, and alterations such as the removal of at least one window. The surface of the limestone is also weathered and soiled in several locations. There is some organic growth on the courtyard walls. The courtyard wall tend to absorb a great amount of moisture. This has resulted in the wall having to be rebuilt two times in the last twenty years.

- Brick – Both the Chicago common brick and Roman brick appear to be in good condition with some areas of staining and soiling observed. There is also some efflorescence on the common brick on the south wall.

- Door – The door is in good condition with only small nicks and scuffs. The finish is also slightly worn on the bronze hardware.
- Windows – The windows appear to be in good condition. The paint finish is slightly worn and cracked in some locations.

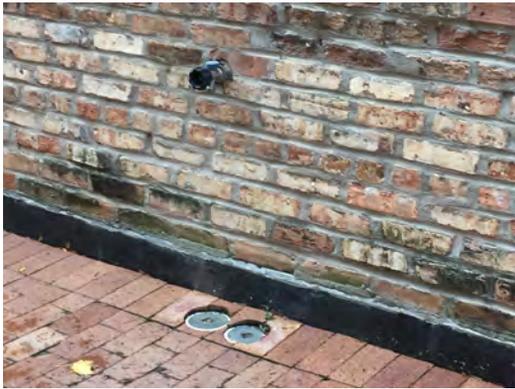
5-27
Left: Soiled brick at the base of the wall, 2016, Harboe Architects.

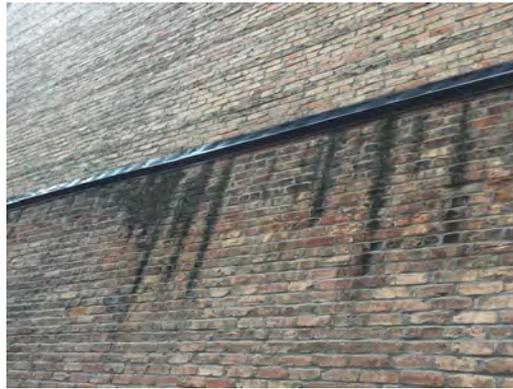
5-28
Right: Staining on the brick wall, 2016, Harboe Architects.

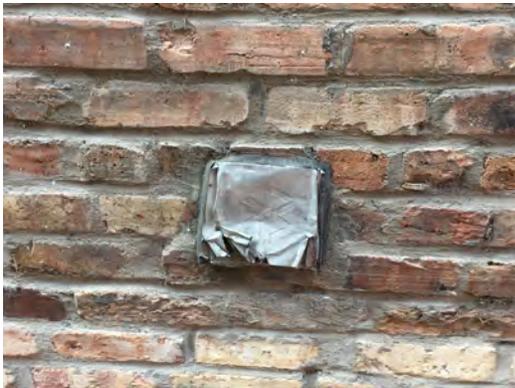
5-29
Left: Damaged metal vent on east facade, 2016, Harboe Architects.

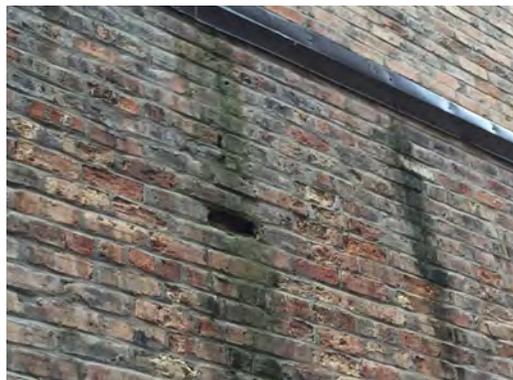
- Brick – The brick is generally in good condition. There are multiple stains from water runoff from the copper flashing. There is also a missing brick twenty-two courses above the door.
- Door – The door is in good condition with only small nicks and scuffs. The finish is also slightly worn on the bronze hardware.
- Window – The window appears to be in good condition.
- Copper flashing – The metal flashing at the second floor appears to be in good condition. It is causing staining on the brick.
- Aluminum vents – There is a metal vent near ground level that is damaged.

5-32
Right: Missing brick on east facade, 2016, Harboe Architects.

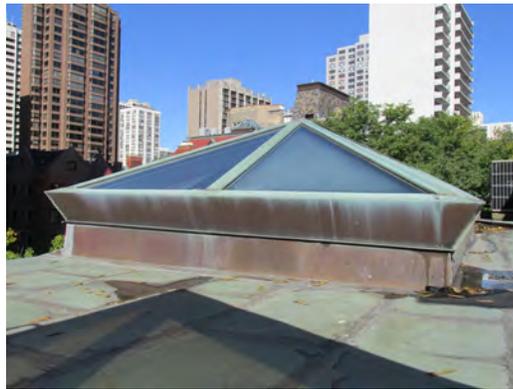
- Chimneys – The brick chimneys appear to be in fair condition. Some of the mortar joints are deteriorated and require repointing. Drafts from the north chimney have caused freezing of the pipes in the second floor bathroom. The pipes have frozen and broken twice, which caused floods in the library below.
- Skylight – Water is pooling around the edges of the skylight. The skylight is leaking into the stair hall on the south end. Gaps or vents in the skylight area let in debris such as seed pods from the maple tree.

5-36
Left: Skylight,
2016, Harboe
Architects.

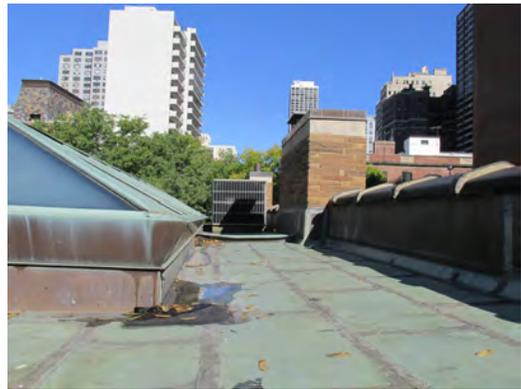
5-37
Right: Water
pooling at corner
of skylight,
2016, Harboe
Architects.

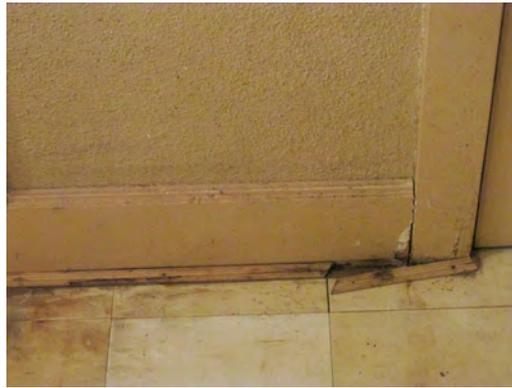
The walls are in fair condition. There are several nicks and scratches as well as areas where the plaster finish coat has scraped off of the wall. The shoe molding on the baseboard is damaged on the east wall.

5-44
Right: Damaged shoe molding on baseboard, 2016, Harboe Architects.

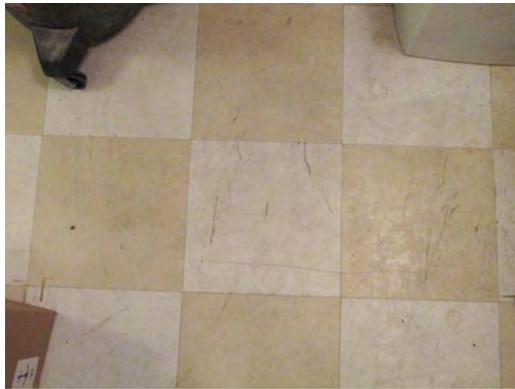
The vinyl tile flooring is in fair condition. It is significantly soiled and scratched. There are also some damaged tiles.

5-45
Left: Scratched vinyl tile flooring, 2016, Harboe Architects.

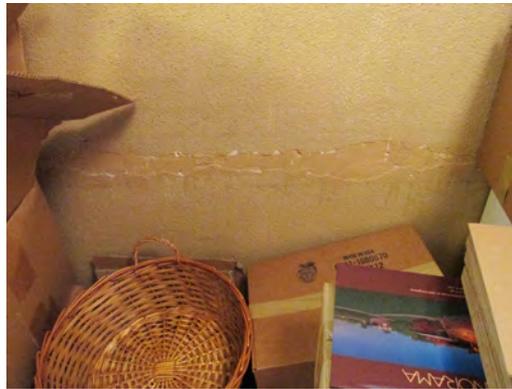
5-46
Right: Damaged painted plaster wall, 2016, Harboe Architects.

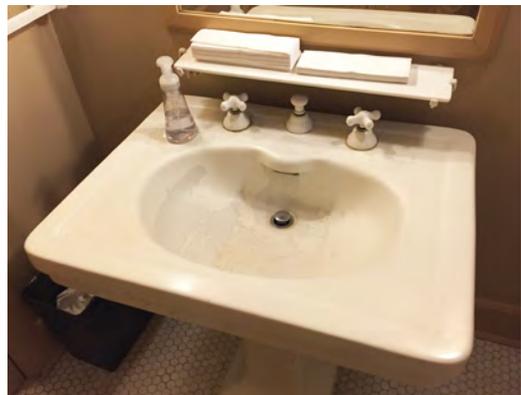
The toilet and sink are in fair to good condition. The porcelain sink was previously refinished. The refinished surface has peeled off in some places.

5-65
Right: Sink in
Toilet Room
2016, Harboe
Architects.

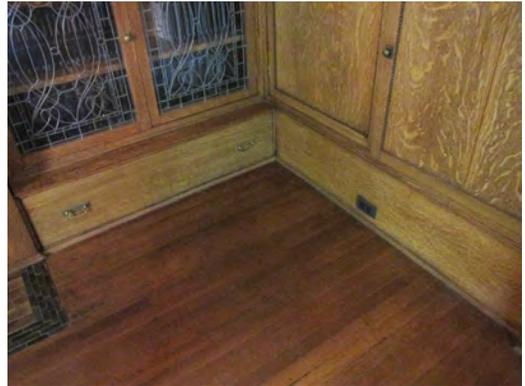
33 George W. Hotchkiss, *Industrial Chicago: The Lumber Interests* (Chicago: Goodspeed Publishing Company, 1894): 452-453.

The floor is in fair condition. It is buckled on the northeast side of the room from floods that occurred in 2014 and before. There is also some general wear including scratches and scuffs, as well as small nicks and holes. The bronze grate is from the 1980s renovation and is in good condition. It is tarnished and has some scratches.

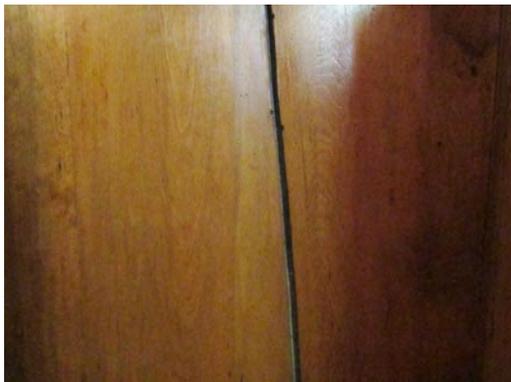
Right: Douglas Charnley, ca. 1915, Ancestry.com.

The wood baseboards, chair rails, cornice, and other trim are in good condition. There is a gap where the cornice meets at the southeast corner. The bookcases are in fair condition. There are splits in the wood backs of the cabinets and book shelves. Also, there are splits in the wood veneer on the cabinet doors.

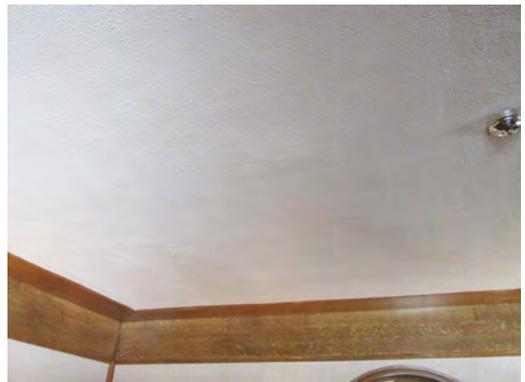
³⁶ Yale University Obituary Record of Graduates Deceased During the Year Ending July 1, 1928 (Yale University: New Haven, 1928): 143-144.

Overall, the painted plaster ceiling is in good condition. There are some small cracks and chips in the plaster and paint.

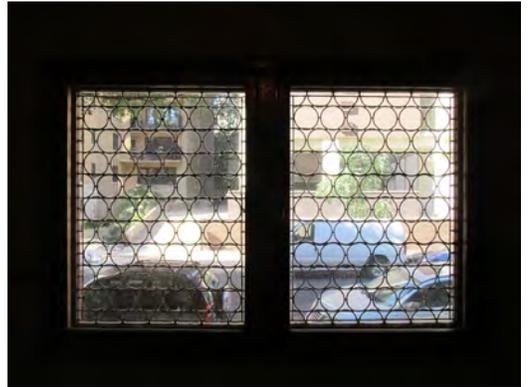
5-98

The windows are in poor condition with some sagging comes. Decades ago horizontal bars were added to stabilize the windows but they obstruct the design.

Right: Alcove window, 2016, Harboe Architects.

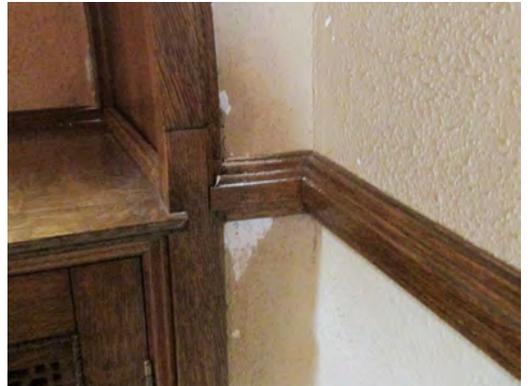
5-100

The painted plaster walls are in fair to good condition. There are several locations where the paint and/or plaster is chipped, especially at edges and the lower part of the wall. There are also some small screw holes and devices attached to the walls. There is a previous patch above and to the left of the main door transom, as well as some minor hairline cracks in the skim coat.

Right: Chipped paint on wall next to niche, 2016, Harboe Architects.

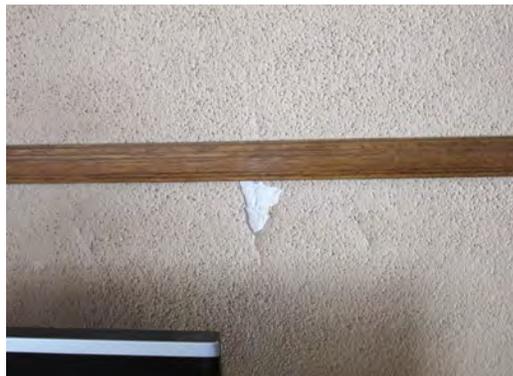
5-101

Left: Chipped paint in north Alcove, 2016, Harboe Architects.

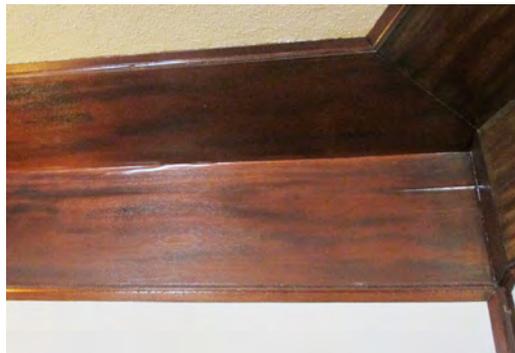
5-111

Left: Warped wood frieze, 2016, Harboe Architects.

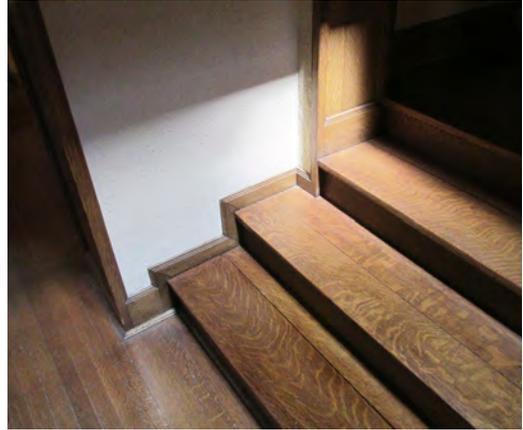
5-120

The steps are in fair condition. The first three treads that lead up to the landing from the first floor hall are split. The condition of the steps under the runner was not surveyed.

Right: Wood stair treads between first floor and landing, 2016, Harboe Architects.

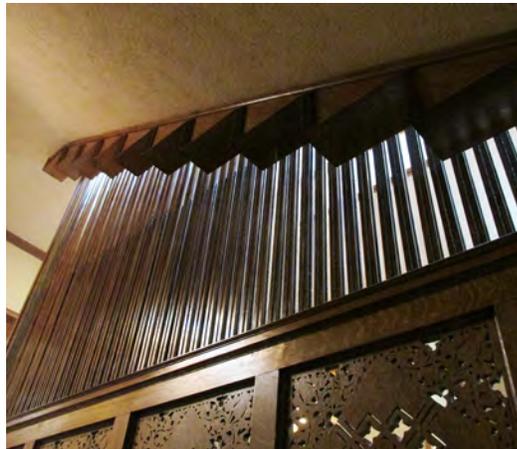
5-123

The railing is generally in good condition. The finish is slightly worn and there are some scratches. The finish on the mounting brackets is worn.

Left: Wood railing and screen 2016, Harboe Architects.

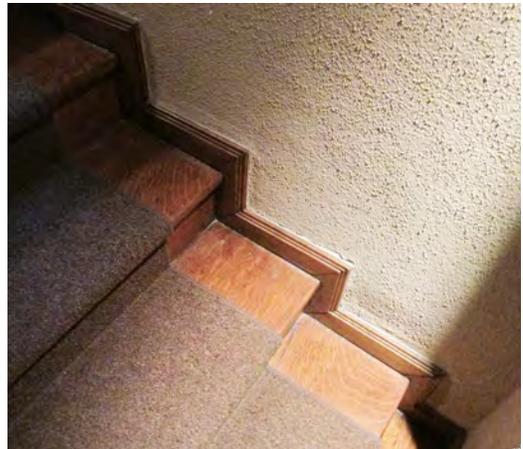
5-124

The painted plaster walls are in fair to good condition. There are several locations where the paint and/or plaster is chipped.

Right: Stair treads and plaster wall, 2016, Harboe Architects.

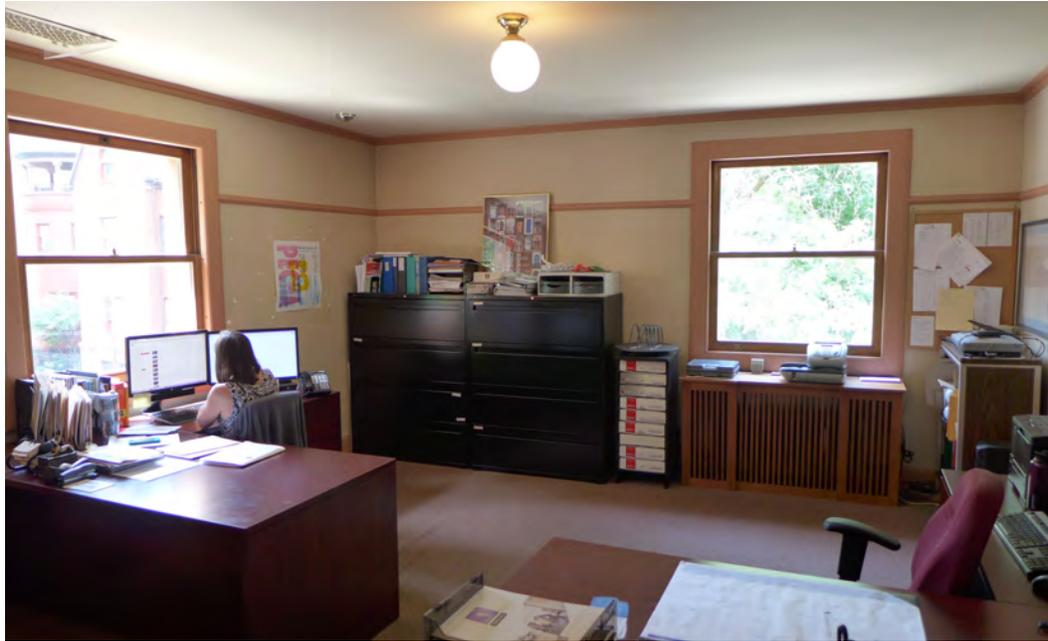
The carpet is in poor to fair condition. It is heavily worn near the desks.

5-126
Second floor office looking northwest, 2016, Harboe Architects.

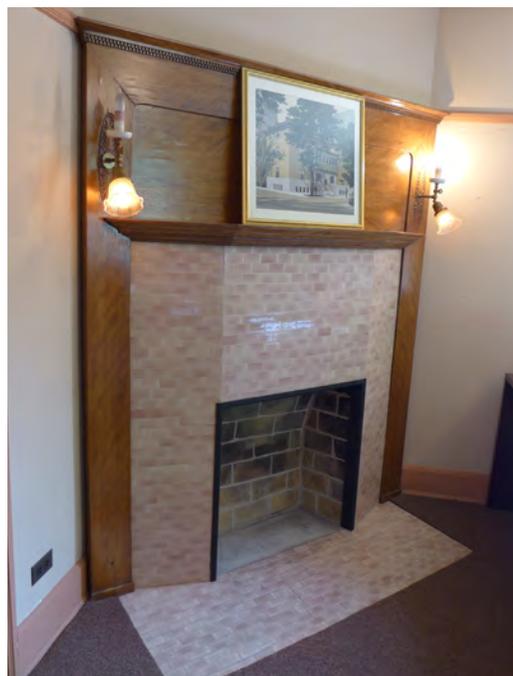
The fireplace is in relatively good condition. Some of the tiles are cracked.

5-127
Fireplace in second floor office, 2016, Harboe Architects.

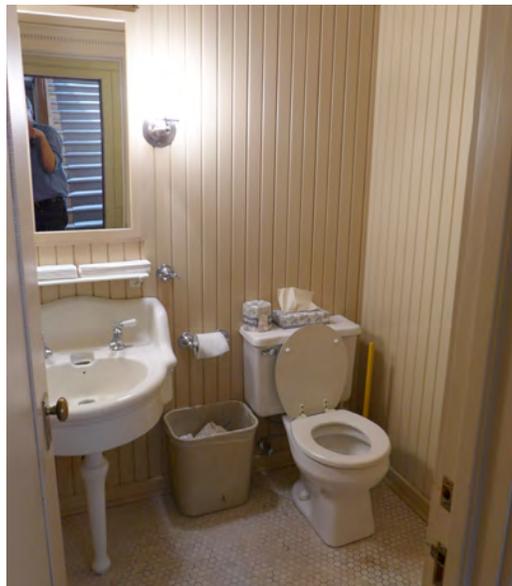
5-132

The wood wainscot is in good condition with minor nicks, scratches, and scuffs. The painted plaster is in good condition except for a vertical crack on the north wall. The metal grate is in good condition.

The toilet and sink appear to be in good condition. The plumbing inside the wall needs to be studied further because the pipes can freeze and break, causing floods in the living room/library below.

Second floor
Toilet Room,
2016, Harboe
Architects.

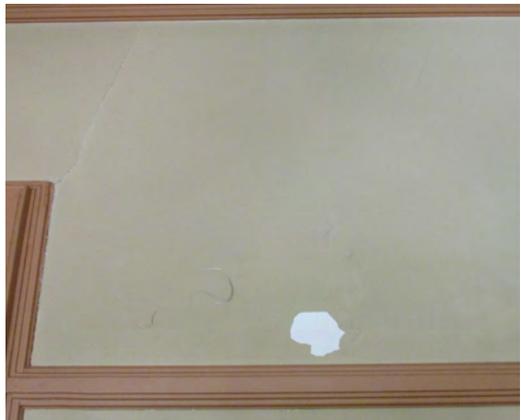
5-148

Right: Peeling paint on north wall, 2016, Harboe Architects.

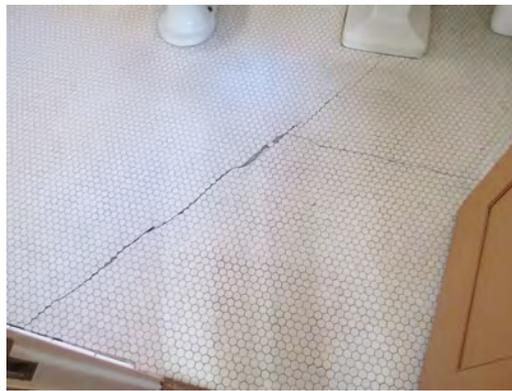
5-153
Right: Crack in tile floor, 2016, Harboe Architects.

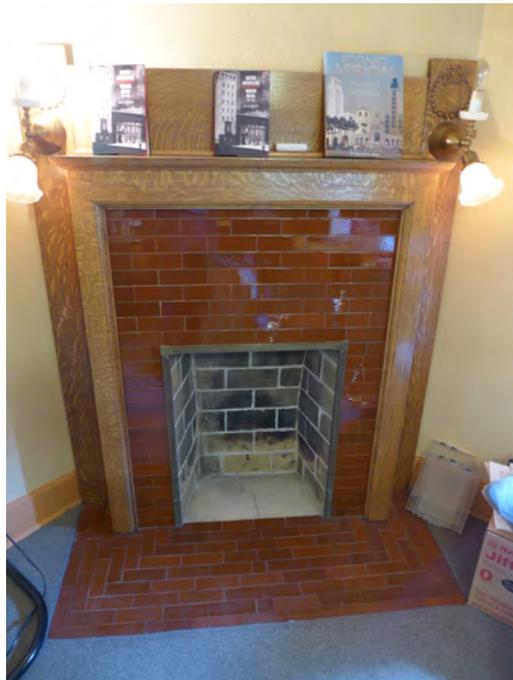
5-159

The fireplace is in relatively good condition. The glazing is worn off on some of the tiles. The concrete floor of the fireplace is cracked.

Third floor Office fireplace, 2016, Harboe Architects.

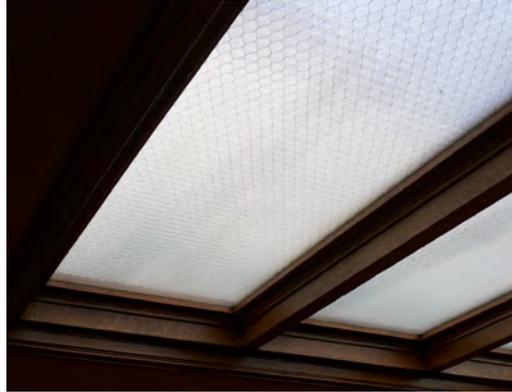
5-165

The laylights are in good condition. The wood frame is in good condition. There is cracked/chipped paint on the frame.

Upper Right: Glass panel at ceiling, 2016, Harboe Architects.

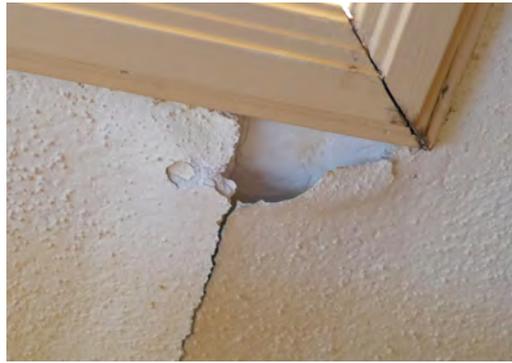
5-166

The ceiling is in fair condition. There is some cracking and delamination of the plaster skim coat around the frame for the glass laylights.

Lower Right: Peeling paint at ceiling, 2016, Harboe Architects.

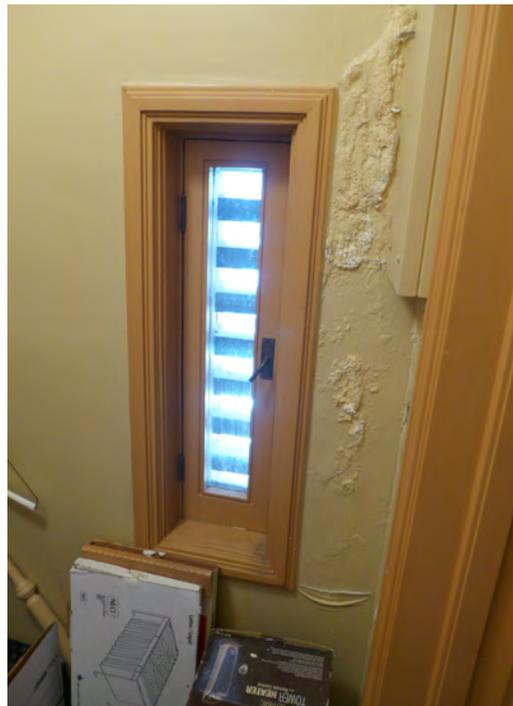
5-168

The plaster is water damaged in the northwest corner of the closet. This is likely due to a leaking internal downspout. The remaining plaster appears to be in good condition.

Water damaged plaster in the Closet, 2016, Harboe Architects.

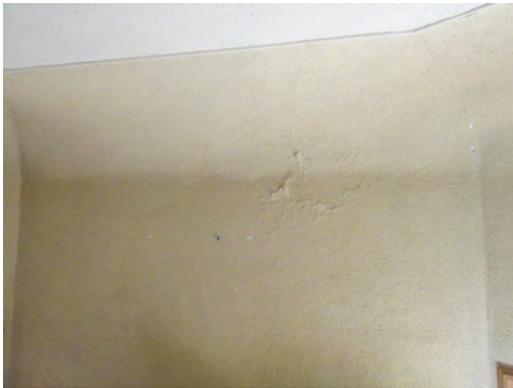
5-183

Left: Water damaged plaster on south wall, 2016, Harboe Architects.

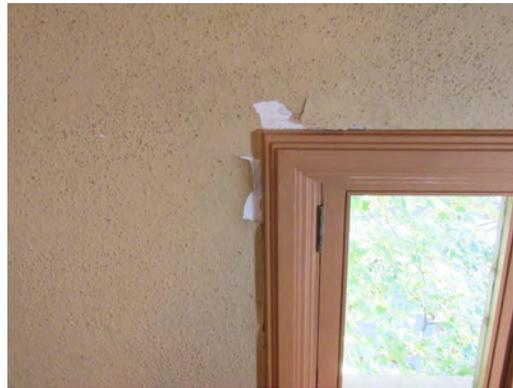
5-184

Right: Peeling paint around window frame, 2016, Harboe Architects.

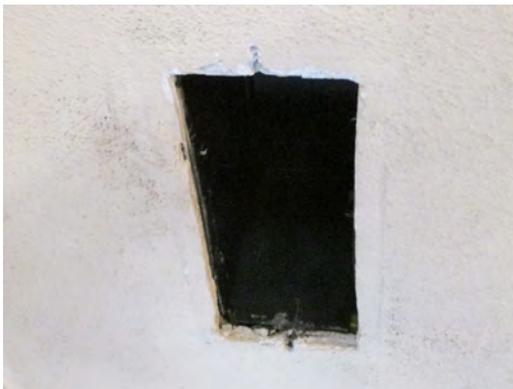
5-185

Left: Missing A/C register cover, 2016, Harboe Architects.

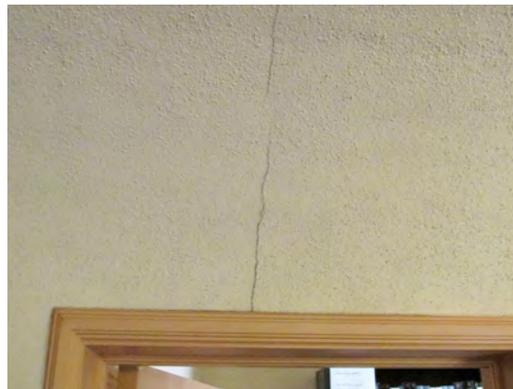
5-186

Right: Crack in wall above door to storage room, 2016, Harboe Architects.

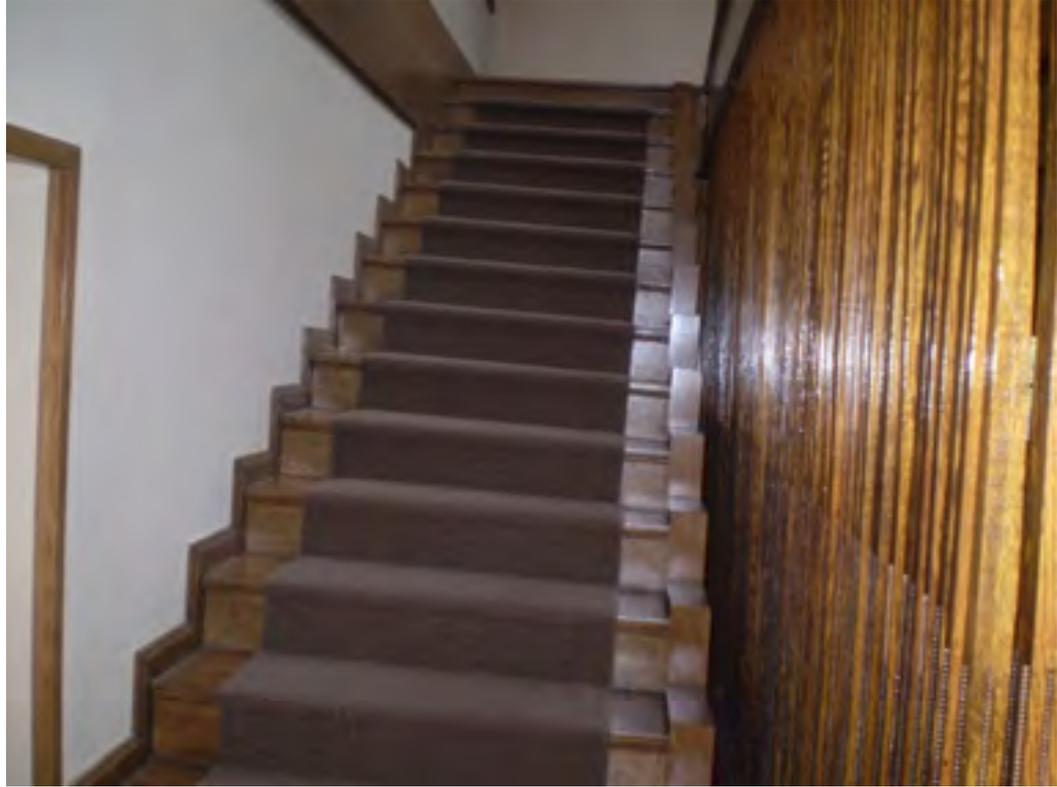
5-192
Stairs from 2nd
floor to 3rd floor,
2016, TGRWA.

The drawings for the 1988 restorations included notes indicating the stair was to be jacked to a level position, steel reinforcing was to be installed, and then the underside was to be re-plastered. According to architect John Eifler, this work was completed on the stairs running between the second and third floors.

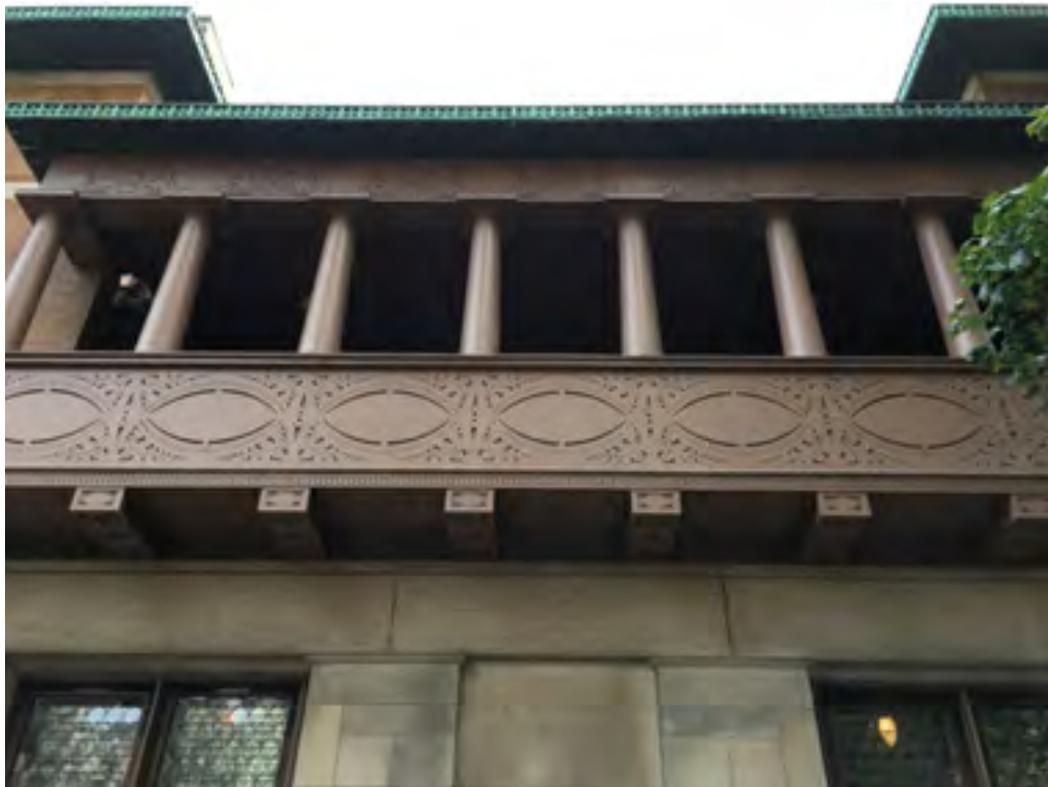
5-194

We viewed the architectural finish materials for signs of possible distress, deterioration, or compromise to the underlying structural elements. However, none was observed.

Balcony, 2016,
Harboe Archi-
tects.

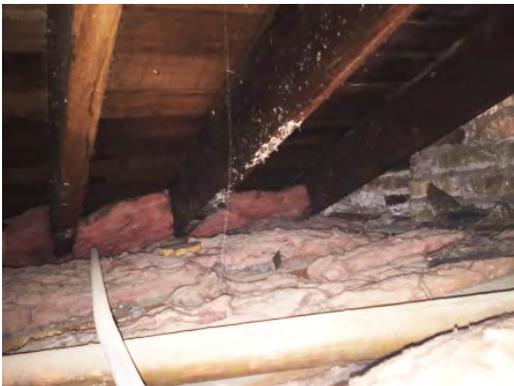
5-199
Left: Fungus on roof joist in attic, 2016, Architectural Consulting Engineers.

There does appear to be some white mold or fungus growth on one of the roof joists (Figure 5-196) which could be indicative of past moisture infiltration and a poorly ventilated attic space in this area of the roof. There is also excessive corrosion on the copper vent piping (Figure 5-197) that could either be moisture condensation caused by a humid attic and cold vent pipe or it could also be poor flux removal from when the pipe joint was soldered.

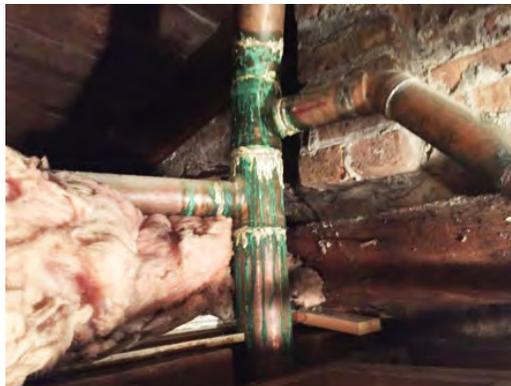
5-200
Right: Corroded plumbing vent pipe in attic, 2016, Architectural Consulting Engineers.

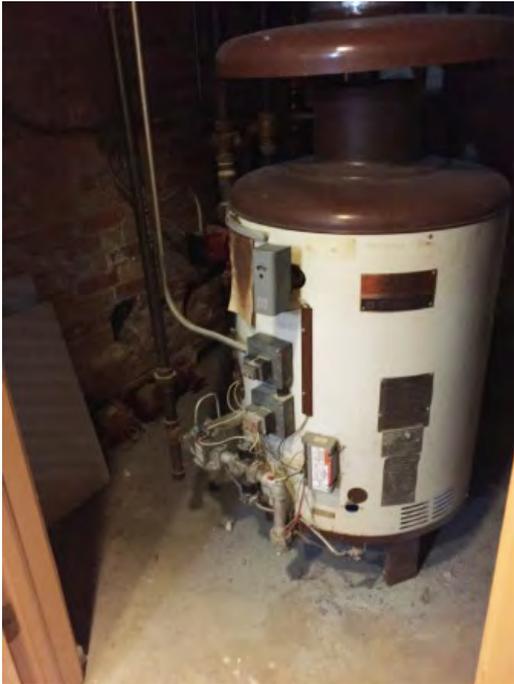
A single hot water heating boiler sits in the basement mechanical room. The boiler is a natural draft model, A. O. Smith, Model HW420-780J with an input of 420 MBtuh and an output capacity of 336 MBtuh providing a nominal efficiency of 80%. The boiler is an older model, dating from 1987, that has seen significant service. At a service life of 30 years, the boiler is approaching the end of its expected useful life and while with regular maintenance it could continue operating for a few more years it should be considered for replacement in the near future in order to avoid an emergency repair or replacement, especially since the one-boiler format offers no redundancy or back-up capability. An added bonus of replacing the existing boiler would be the ability to install a more fuel efficient model and possibly change the system into a multiple boiler configuration which would enhance system reliability – all of which should save on operating costs.

Left: Boiler, 2016, Architectural Consulting Engineers.

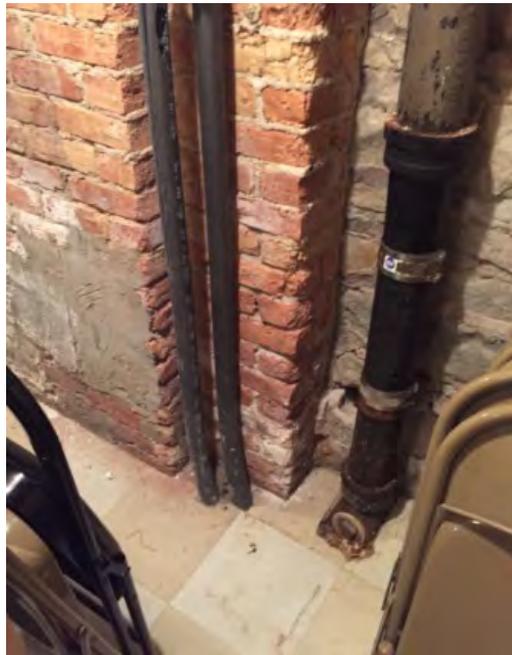
The plumbing systems in the building appear to have been largely replaced when the building was renovated in the 1980's although despite the drawings calling for the sanitary & vent risers to be replaced there is evidence some cast iron waste and vent stacks may remain in use. These heavy cast iron stacks are generally good for 100 years or more of service so there is not too much concern with their continued use.

Left: Old cast iron stack connected to new at base, 2016, Architectural Consulting Engineers.

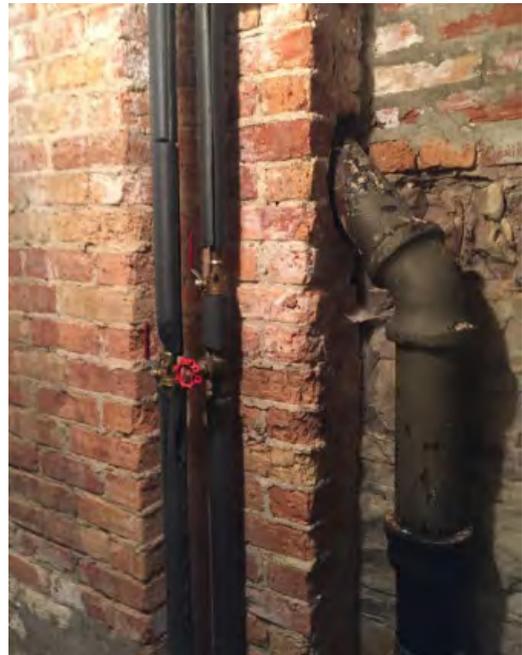
Right: Cast iron stack from second floor toilet room above attic, 2016, Architectural Consulting Engineers.

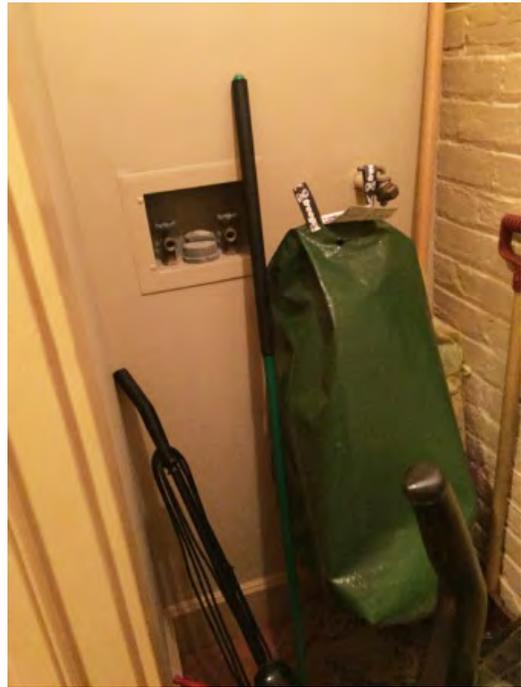
Right: Abandoned grey box, 2016, Architectural Consulting Engineers.

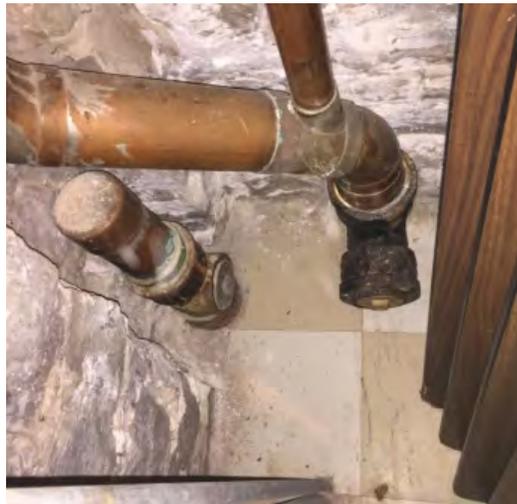
The 1980's renovation called for replacement of the storm water downspouts and separation of the interior storm and sanitary piping below grade until reaching the exterior wall on the north side and the courtyard on the south side. We suspect that basement water infiltration continued to be a major issue because in a project in 2001-02, additional changes were made to the storm water system creating a separate storm sewer in the alley flowing north to the combined street sewer in Schiller Street. An interior downspout in the NE corner of the building and an exterior downspout in the SE corner of the building were connected to this new storm sewer and their original below grade piping was capped and abandoned in place. An interior downspout on the south west side remains connected into the sanitary sewer which flows to the courtyard area and an interior downspout on the north west side remains connected into the sanitary below the north basement storage room floor and exits the building to the west.

Left: Redirected storm drain at northeast interior corner, 2016, Architectural Consulting Engineers.

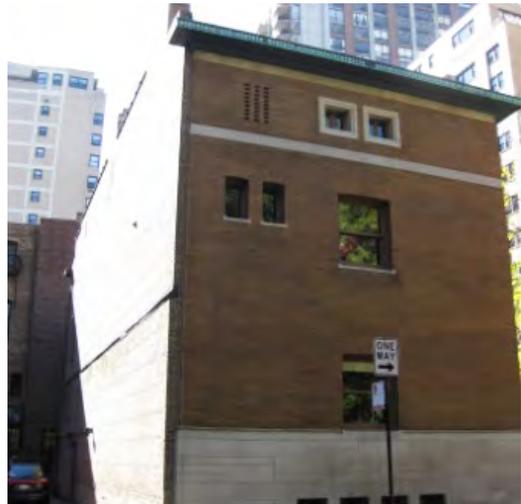
Right: Exterior redirected downspout at southeast corner, 2016, Architectural Consulting Engineers.

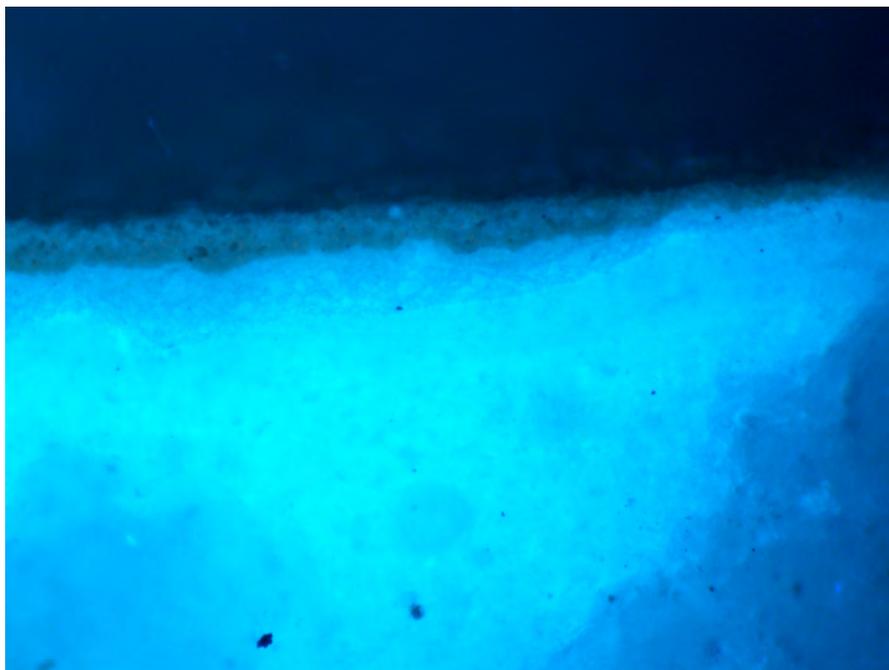
Sample CPH-5, taken by BCA during the site visit, is not representative of the original wall finish. The photomicrograph of the cross-section shows a plaster substrate that looks nothing like that seen in the cross-sections of the archived samples that contain original material; the plaster of the new sample is smoother and without distinct sand grains (Figures 1 & 2). Furthermore, there are very few paint campaigns or layer sequences, so it can be assumed that the area from where CPH-5 was taken is an area of replaced plaster.

Figure 1. Sample CPH-5 (first floor hallway, 100x, visible light). This sample does not contain original material and was taken from an area where the original plaster has been replaced. The composition of the plaster substrate appears different than the other samples seen in cross-section that were taken from the archived collection and contains only two layers of modern paint.

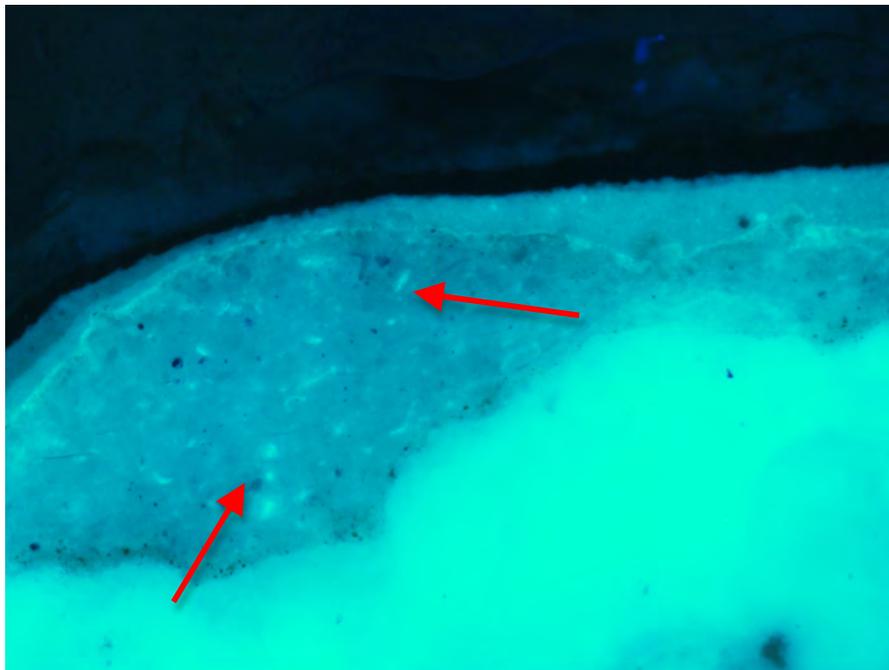
Sample CP-B-4-d, from the living room, was selected for its accompanying note on the inventory list stating it is a good example of the “first calcimine layer” and was taken from “behind molded trim”. The cross-section photomicrograph of CP-B-4-d (Figures 3 & 4) confirms the presence of

Figure 3. Sample CP-B-4-d (living room, 50x, visible light). In cross-section the original possible distemper color does not look like the light brownish pink described by Furhoff and verified by BCA. Distempers are also prone to soiling over time and appear soft or pillowy in appearance in cross-section, as opposed to oil paints, which have more clearly delineated boundaries.
