CHARNLEY-PERSKY HOUSE

CONSERVATION MANAGEMENT PLAN

The Charnley-Persky House is one of the most significant buildings in the early development of modern residential architecture in America. Designed by renowned late nineteenth century architecture firm, Adler and Sullivan, the house was completed in 1892 for Mr. and Mrs. James Charnley. Although the lack of physical evidence such as architectural drawings makes the authorship of house unclear, it is widely believed that there are design features and elements that can be attributed to both Louis Sullivan and Frank Lloyd Wright. The house, which is located in the Astor Street Historic District, was twice designated a City of Chicago Landmark in 1960 and 1972, was listed on the National Register of Historic Places in 1970, and was designated a National Historic Landmark in 1998.

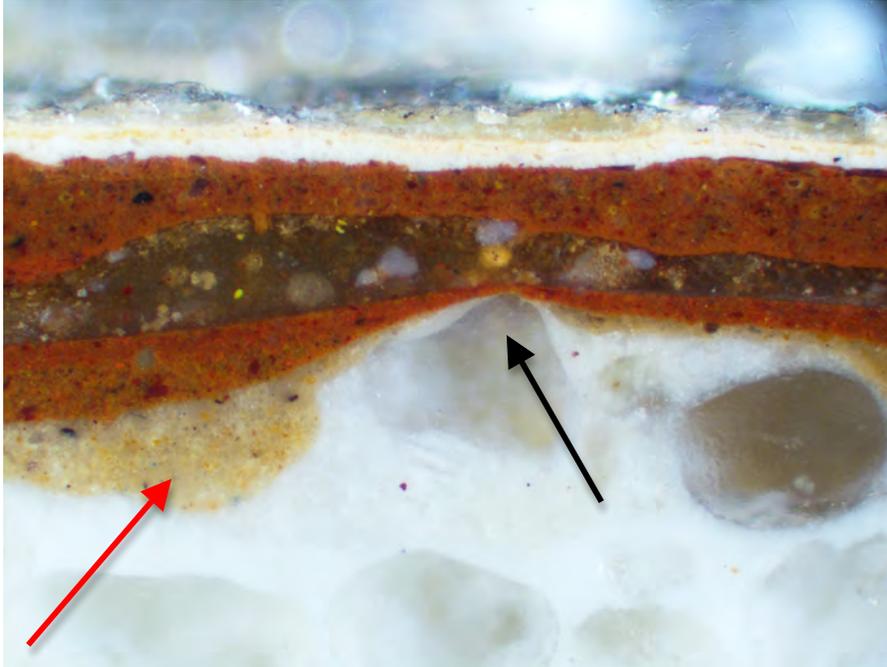
Figure 8. Sample CP-B-2-c, 1st floor hallway (50x, visible light). This is a good example of the uneven sand float plaster finish with protruding sand grains in cross-section. Similar to the Entrance Vestibule samples discussed in the next section, there is more paint accumulation in the “valleys” between the sand grains (where the red arrow is pointing) than where the grains protrude (black arrow). In those areas where the grains protrude, there is little to zero finish.

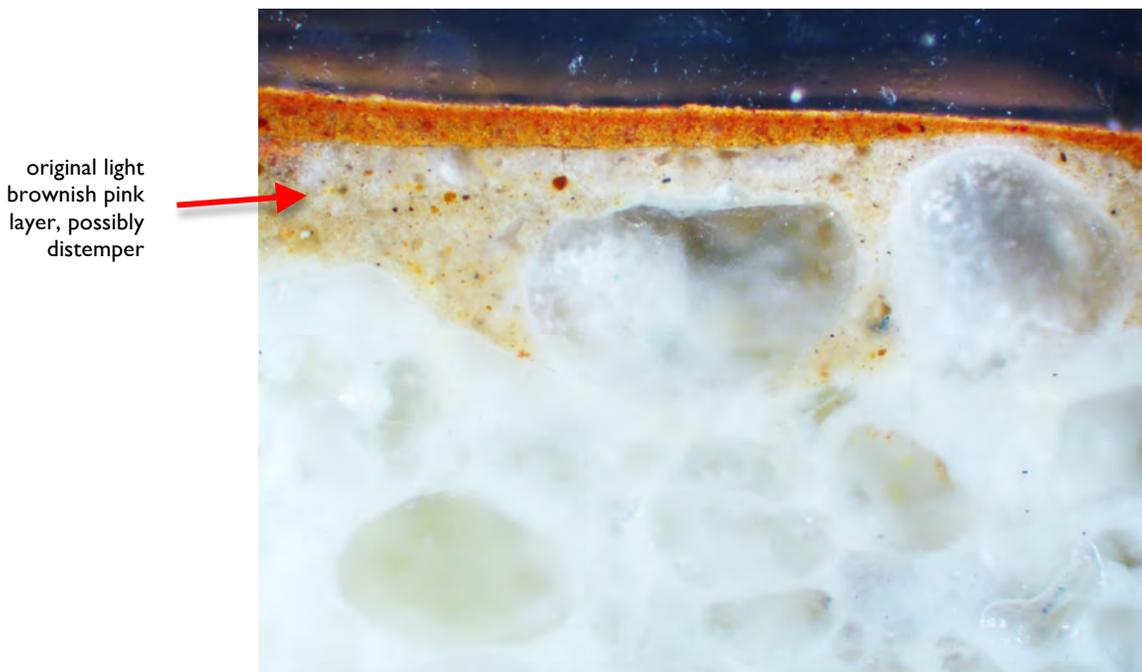
Figure 9. Sample CP-B-3-c, 1st floor alcove wall (50x, visible light). Again, the original light brownish pink layer surrounds the individual protruding grains of sand.

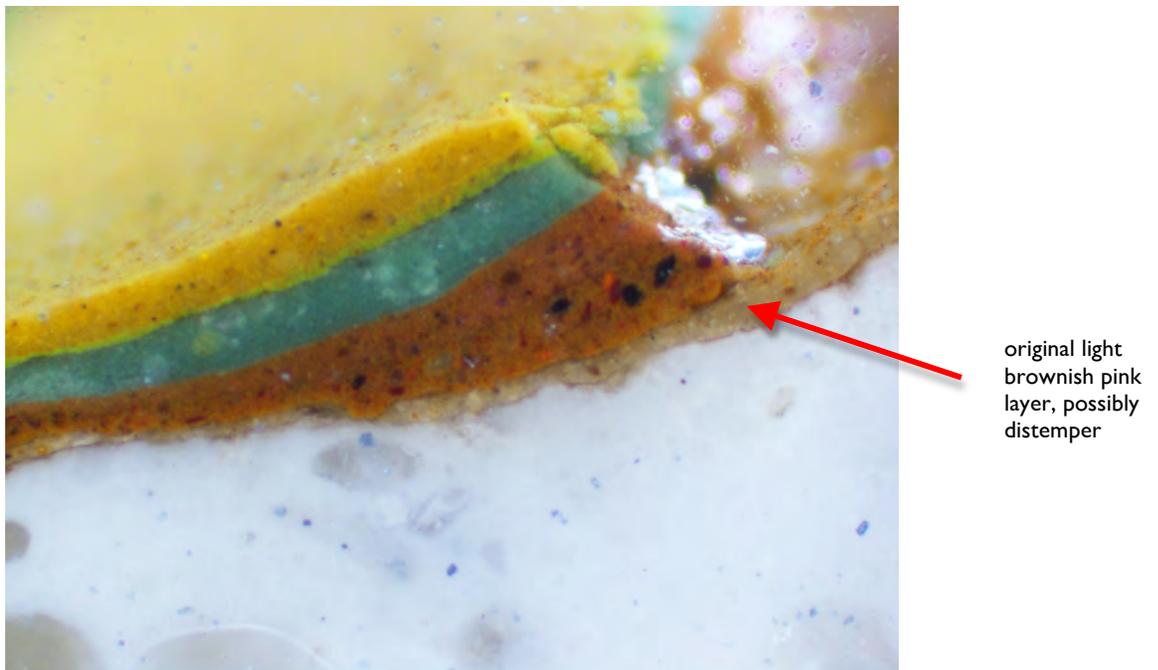
One archived bulk collection sample from the second floor hallway wall was embedded in cross-section for comparative purposes (Figure 10). CP-C-1-g was chosen from the inventory because “good sample of cal [sic.] color” was annotated on the list. Furhoff must have taken this from higher up on the wall closer to the ceiling because “above trim/frieze” is also written on the sample envelope. Similar to sample CP-B-4-d that Furhoff took from behind a piece of trim in the living room, this sample has a more smooth plaster texture but is a good representative of the original color. It seems to have been taken from a corner or behind a trim because the sand float plaster finish is not as apparent. The color matches the other samples.

Figure 10. Sample CP-C-1-g, second floor alcove wall “above trim” (50x, visible light). In this portion of the cross-section the texture is smoother and the grains of sand do not protrude as much as seen in other samples. This is most likely because it was behind a trim or from a smoother corner.

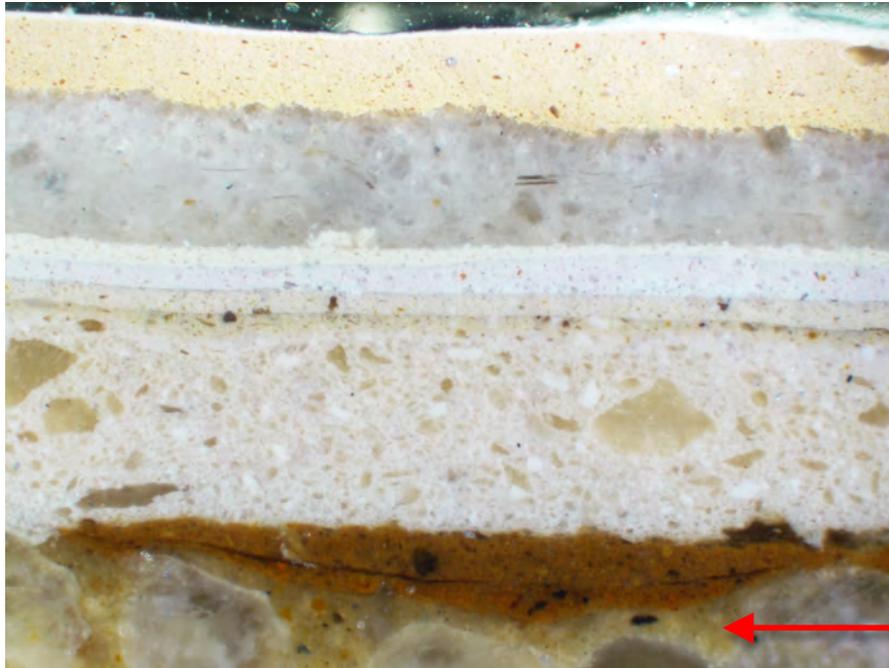
Figure 11. Sample CP-D-1-g, 3rd floor hallway wall above frieze trim (50x, visible light).

Samples CP-D-1-g (third floor hallway wall, above frieze trim), CP-D-1-d (third floor hallway wall from behind cornice molding), and CP-D-2-b (third floor hallway alcove wall) again show consistency in their original decorative scheme. The light brownish pink translucent layer is observed in and around the sand grains in the sand float plaster finish (Figures 11, 12, 13).

original light brownish pink layer, possibly distemper

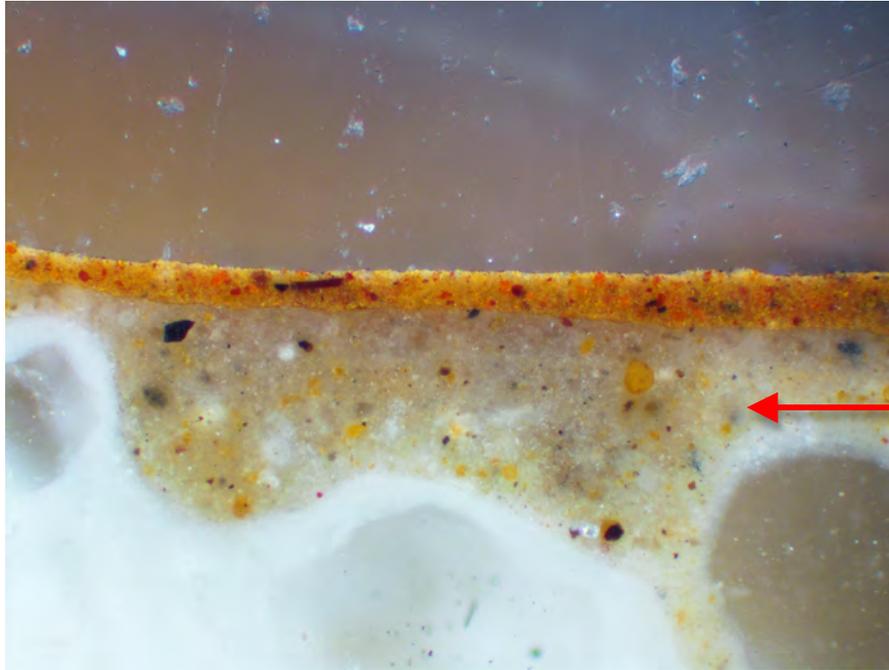
Figure 12. Sample CP-D-1-d, 3rd floor hallway wall (100x, visible light).

original light
brownish pink
layer, possibly
distemper

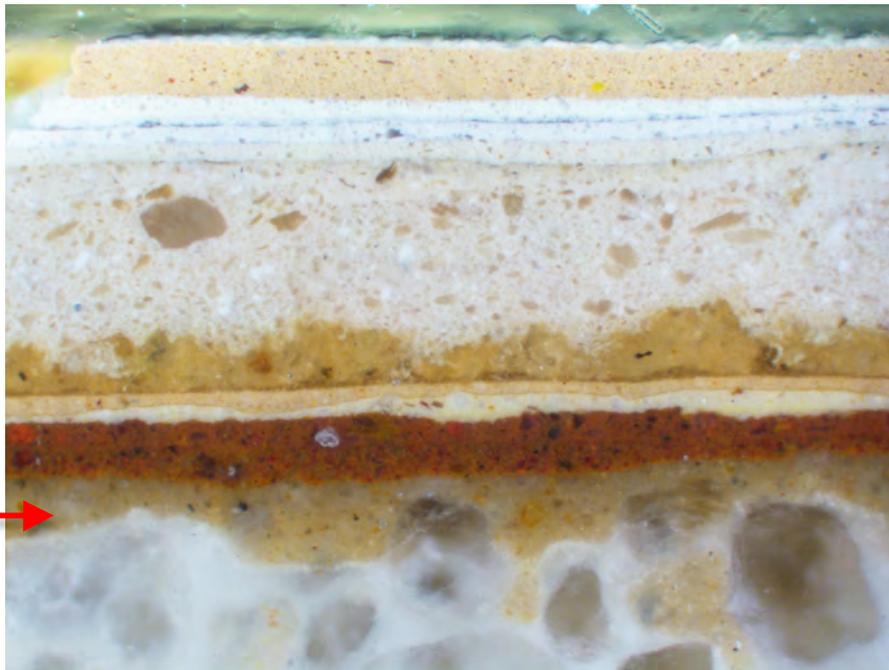
Figure 13. Sample CP-D-2-b, 3rd floor hallway alcove wall (50x, visible light).

original light
brownish pink
layer, possibly
distemper

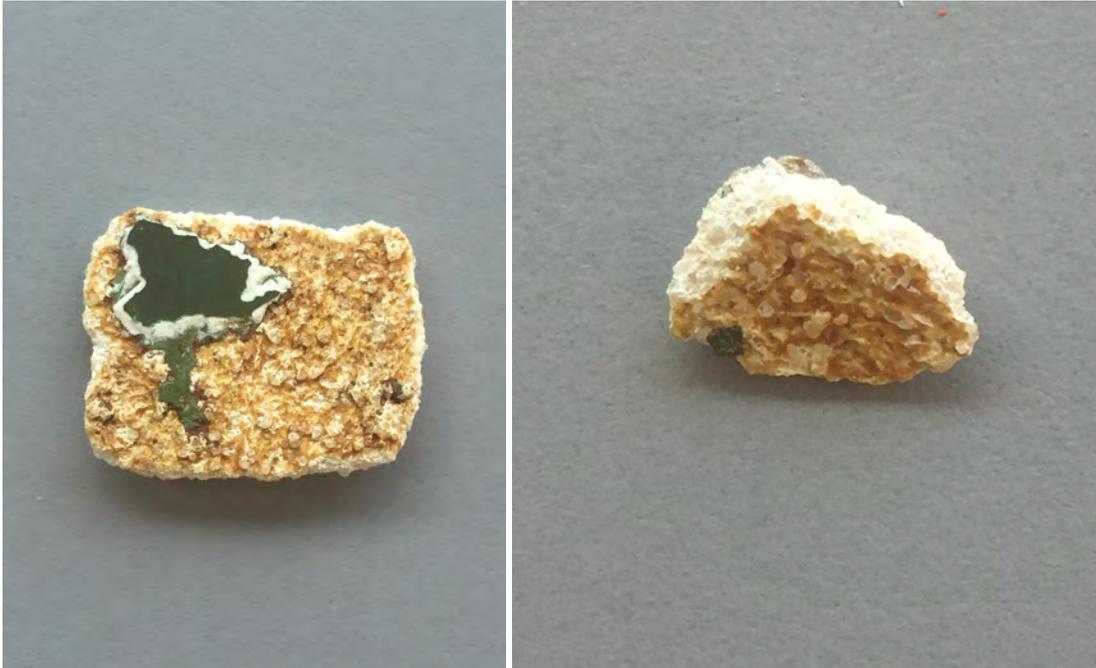
A cross-section analysis of the corresponding entrance vestibule wall sample from the archived sample collection was not performed. However, visual analysis of the archived sample in its bulk form both under the microscope and with the eye confirms Furhoff’s report conclusions (Figure 15). Furhoff had exposed the original layer by removing the later paint layers. The texture of the plaster can clearly be seen as well the thin, uneven application of the resinous layer.

BCA analysis confirms Furhoff’s findings. A layer of a clear honey-colored resin was applied directly to the sand coat finish plaster. Figure 16 is an exposure of sample CPH-6, showing the later paint layers removed and earliest finish layer revealed. When visually compared to Furhoff’s exposed sample, the color and texture of the sand float plaster layer with transparent resin finish is nearly identical. Overall, the resinous application was thin, but photomicrographs of sample CPH-6 in cross-section (Figures 17 & 18) show greater accumulation of the resin in the valleys between the sand grains. There is barely any resin on the tops of the protruding sand grains. Analysis of the cross-section under ultraviolet light did not reveal any significant auto-fluorescing of the original resinous layer (Figure 18); further research and instrumental analysis would therefore need to be performed in order to identify the component material of the resinous layer.

Figures 15 and 16. Figure 15, left, sample CP-B-1-b from the archived bulk sample collection. The sample was sent to BCA in this form in the sample envelope; therefore it can be assumed that Bob Furhoff most likely exposed the original surface. Figure 16, right, sample CPH-6, taken by BCA during the site visit with subsequent exposure performed in the laboratory. The texture of the sand float plaster is clearly seen, with small protruding sand grains creating a rough, uneven surface finish. As expected, the translucent resin shows thicker accumulations in the “valleys” between neighboring sand grains and was spread thinner across the tops of the grains. This finish is difficult to color match overall because a translucent finish cannot be represented by an opaque paint film.

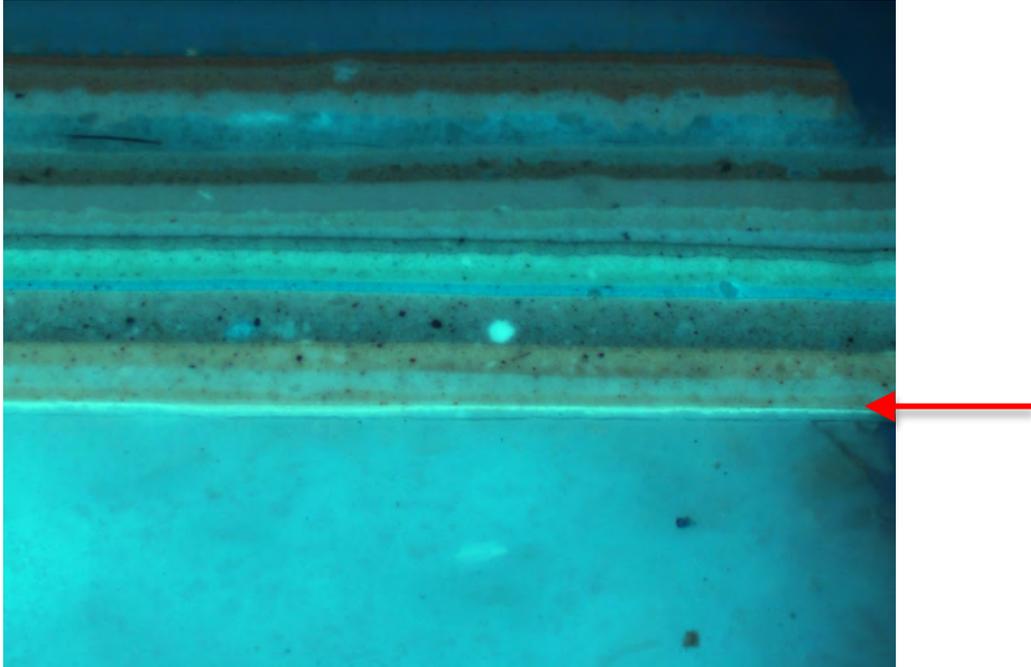
Figure 22. Sample CPH-3 (50x, ultraviolet light). A thin uniform layer is visible below the original light yellowish brown oil paint; it auto-fluoresces a bright green white. Further examination of the bulk sample through exposures revealed that this layer was a translucent size preparation layer and not a finish layer.

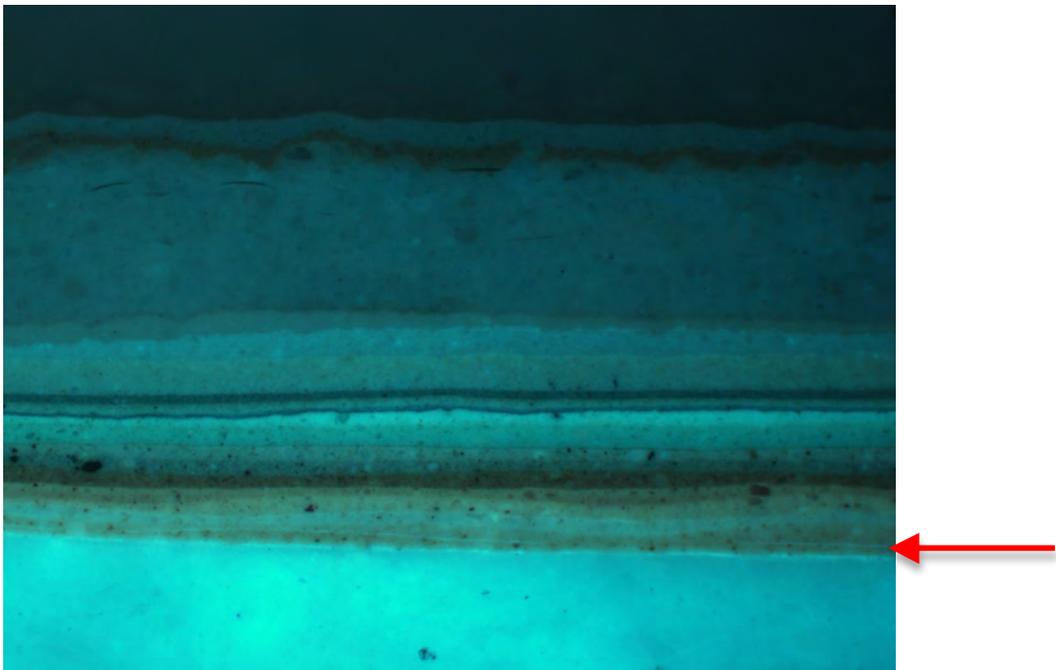
Figure 23. Sample CP-E-2 (50x, ultraviolet light). While not as uniform or apparent as the sample taken from the first floor service stair wall, above, this cross-section taken from the archived collection also shows the early preparation size layer auto-fluorescing in UV light.

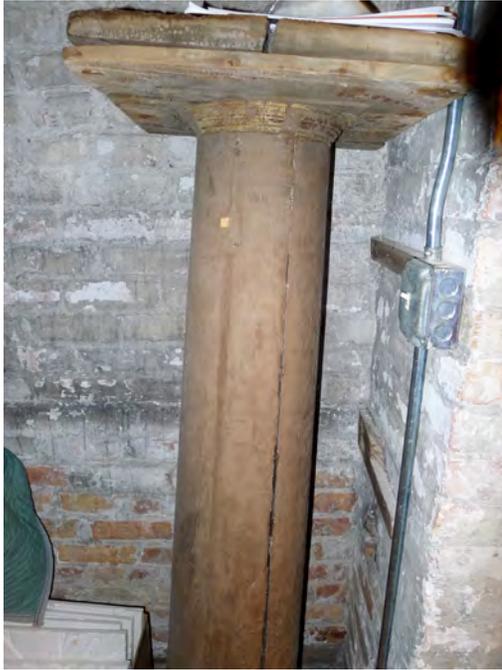
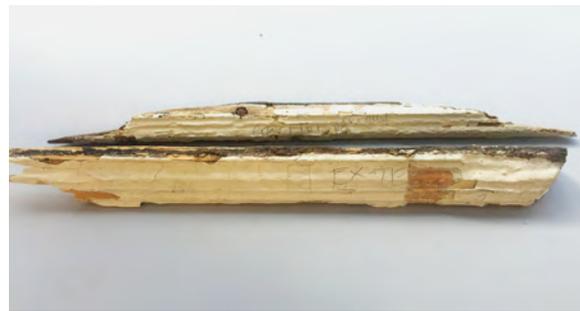
Furhoff did not specifically study the second floor balcony exterior wood elements or discuss them in his report. However, upon BCA's site visit, an original exterior wood column from the second floor balcony that has been stored in a basement closet was brought to our attention and sampled (Figure 24). Despite exclusion from his report, exterior wood trim balcony elements were also found in the archived collection of Furhoff bulk samples (Figure 25). This section of the report is therefore not intended to be verification of Furhoff findings, but a summary of the analysis performed on these new samples.

Figures 24 and 25. Left, original second floor balcony exterior wood column being stored in basement closet, sample CPH-4. Right, second floor balcony exterior wood trim from Furhoff archived sample collection, specific location unknown, sample CP-F-I-2.

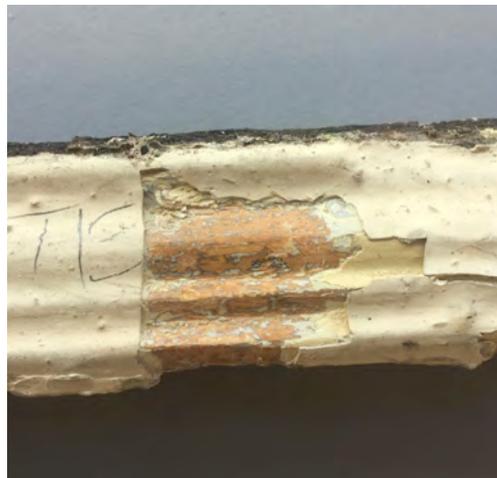
A cross-section of sample CP-F-I-2 shows that the original paint layer was a salmon pink color with traces of an off-white primer (Figure 27). Exposure of the bulk sample confirms the cross-section layer sequencing to reveal the original salmon color (Figure 26).

Figure 26. Sample CP-F-I-2 bulk sample exposure revealing the original salmon color of the exterior wood trim element.

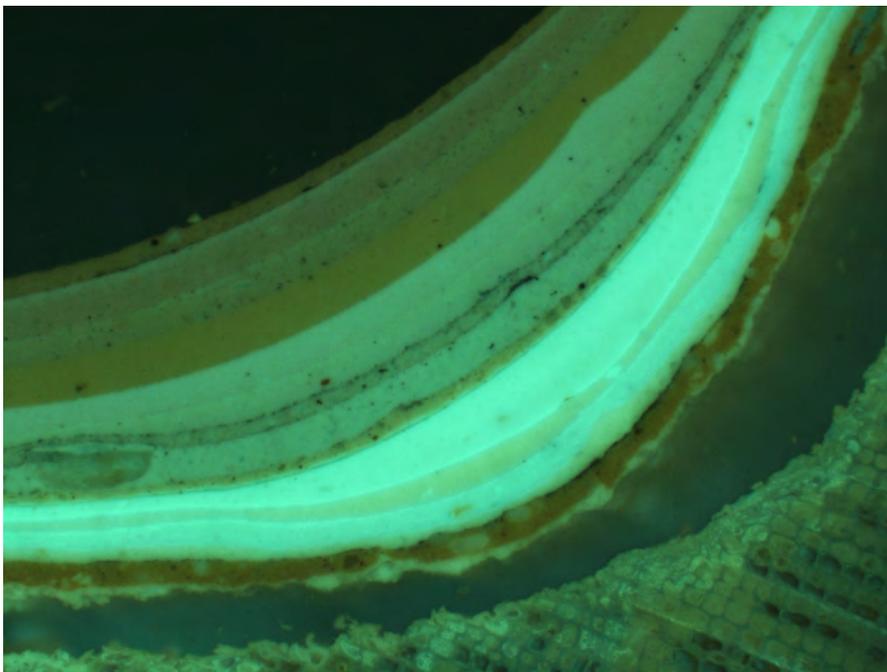
Figure 28. Sample CP-F-I-2 (50x, ultraviolet light). UV light helps aid in further layer distinction throughout the cross-section layer sequencing. No auto-fluorescence of importance is noted on the wood substrate itself or in the original paint layers.

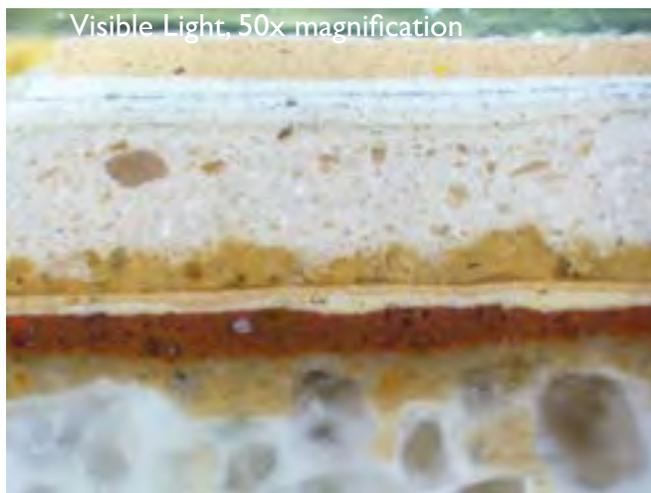
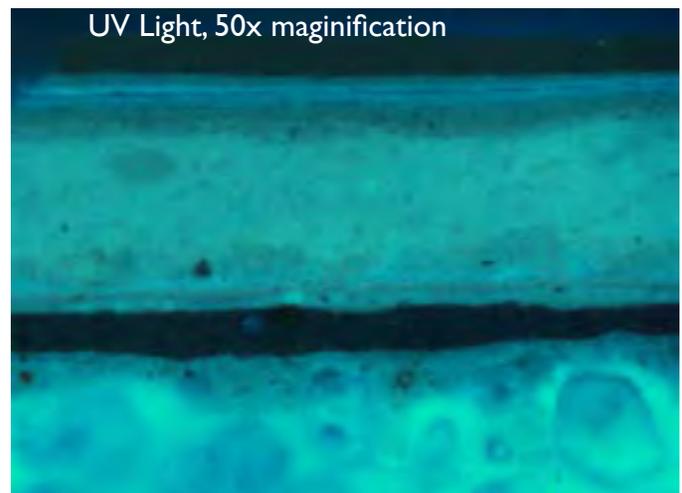
LAYER	REFLECTED LIGHT COLOR	NOTES
Plaster		
I	light brownish pink	possible distemper
2	orange red	
3	dark red	
4	white	
5	peach	
6	tan	
7	off-white	thick
8	off-white	
9	white	
10	white	
11	tan

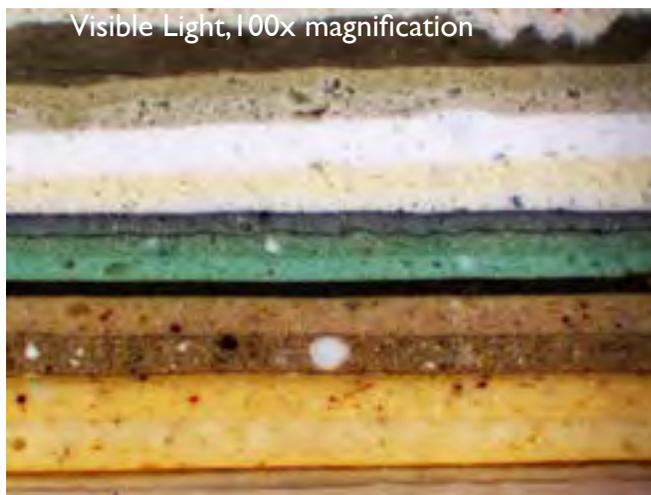
Visible Light, 100x magnification

SAMPLE #: CPH-3	ROOM: back service stairs
DATE SAMPLED: August 2016	DATE ANALYZED: September 2016
SAMPLED BY: D. Krotzer	ANALYZED BY: K. Lenehan
MICROSCOPE: Nikon 50i compound fluorescence microscope	CAMERA: Nikon DigiSight
DESCRIPTION: First floor back service stair hall wall, to right of door into kitchen pantry

LAYER	REFLECTED LIGHT COLOR	NOTES
Plaster		
1	brown	thin, resinous, translucent
2	light yellow	
3	off-white	
4	light yellow	
5	brown	
6	pinkish tan	
7	mint green	
8	mint green	
9	gray	
10	dark gray	
11	white	
12	off-white	
13	white

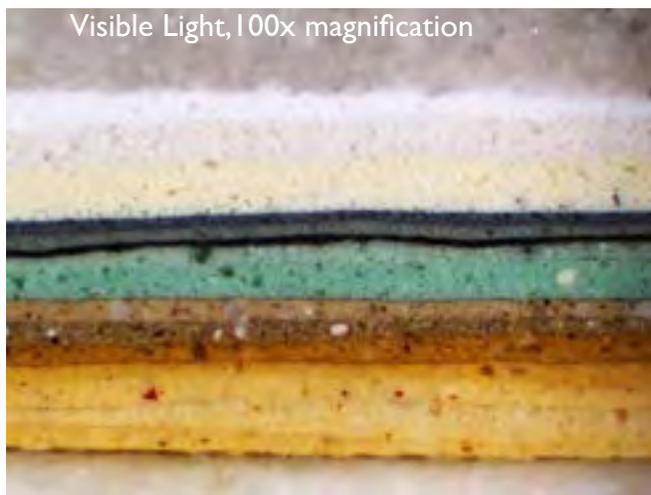
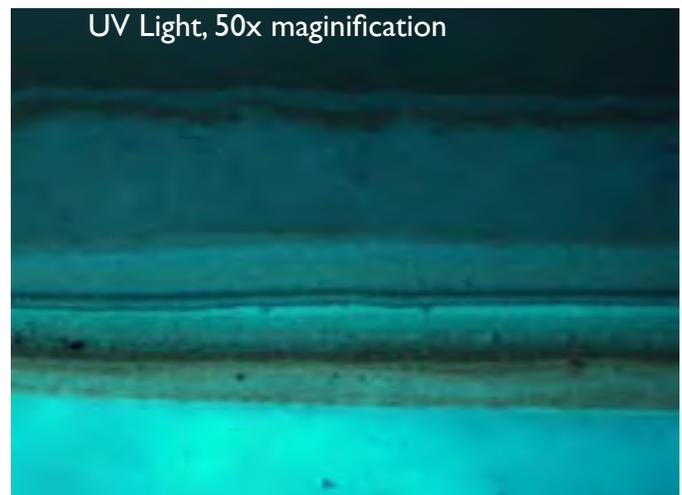
LAYER	REFLECTED LIGHT COLOR	NOTES
Plaster		
1	brown	v. thin, resinous, translucent
2	light yellow	
3	off-white	
4	light yellow	
5	yellow	
6	light brown	
7	pinkish tan	
8	mint green	
9	mint green	
10	black	thin
11	gray	
12	dark gray	
13	off-white

LAYER	REFLECTED LIGHT COLOR	NOTES
14	off-white	
15	white	
16	gray	
17	gray	
18	gray

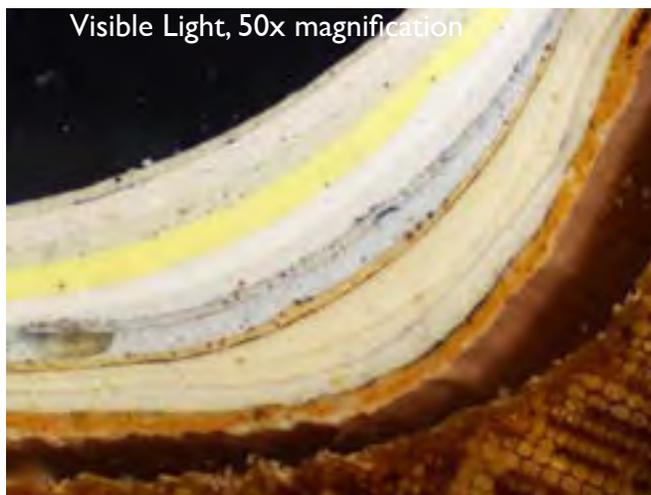
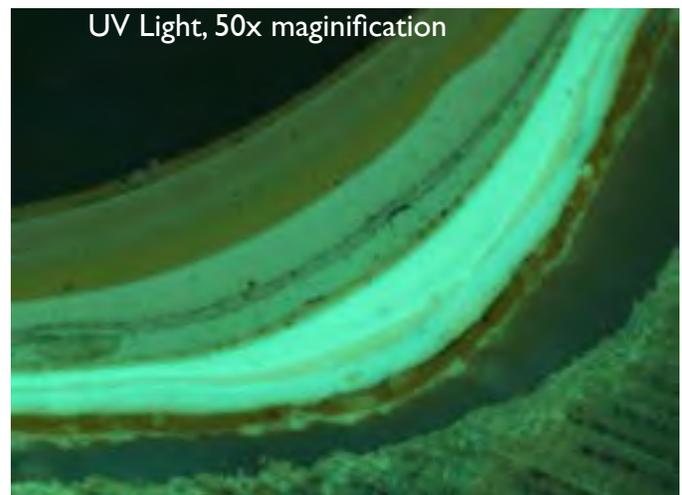
LAYER	REFLECTED LIGHT COLOR	NOTES
Wood		
1	off-white	primer
2	salmon pink	
3	pale light blue	
4	pale light blue	
5	off-white	
6	off-white	
7	glaze	thin brown
8	light pink	
9	light blue	
10	light gray	
11	white	
12	white	
13	lemon yellow

LAYER	REFLECTED LIGHT COLOR	NOTES
14	light gray	
15	white	
16	white

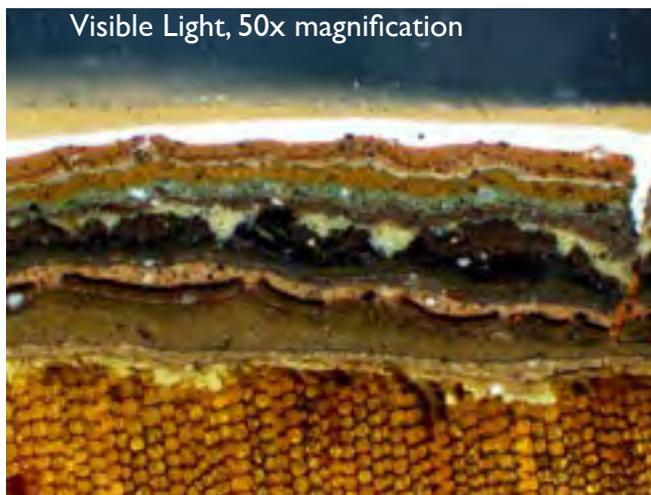
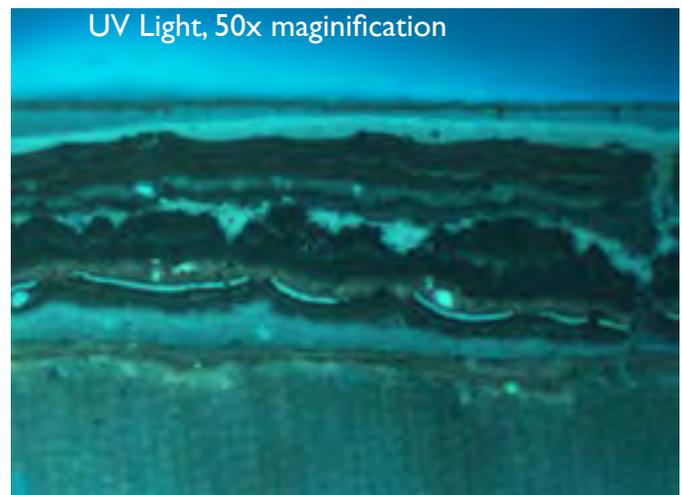
Sample CPH-4 was taken from the exterior column that is currently being stored in the basement closet. The cross-section photomicrograph shows numerous layers of earth-toned painted finishes. The original layer is thin and brown (Figure 30). An attempt to reveal the original color and finish through an exposure of the column bulk sample proved difficult because the original layer is so thin and the wood substrate was extremely soft and deteriorated. The original brown paint most likely served as a protective layer that added a richer color that would have been a slightly darker brown than the wood. The original layer could also be confirmed in the bulk sample when turned on its side to see the paint layer sequencing. Examination of the column itself confirms remnants of the original thin brown paint immediately on top of the wood substrate (Figure 29).

LAYER	REFLECTED LIGHT COLOR	NOTES
Wood		
1	light brown	
2	pink brown	
3	pink brown	
4	brown	
5	dark brown	
6	gray	
7	dark brown	
8	black	
9	salmon pink	
10	gray	
11	dark brown	
12	black	
13	brown

LAYER	REFLECTED LIGHT COLOR	NOTES
14	off-white	
15	brown	
16	off-white	
17	off-white	v. thin
18	green	
19	mustard yellow	
20	white	
21	salmon pink	
22	dk reddish pink	
23	white	
24	brown

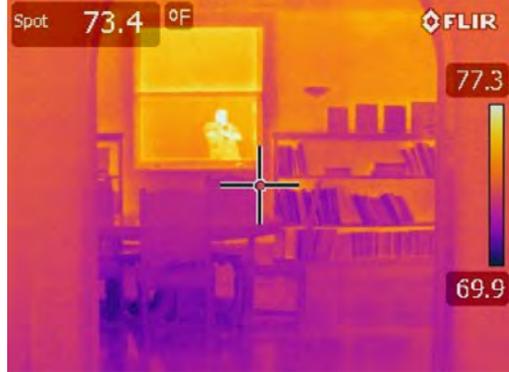
IR_5257.jpg 7/22/2016 9:19:21 AM

We have determined that the building envelope has minimal leakage and is built to a leakage rate just above today's standards. This being said there were some areas in the building envelope mainly the attic that were found to have some defect. These pictures show areas of infiltration during the blower door test

In addition to air leakage we also found evidence of water leakage in the top floor ceiling. . These pictures show evidence of cold water spots into the top floor ceiling.

1. To improve efficiency, comfort and indoor air quality lost due to duct leakage we recommend Aeroseal. Aeroseal sealant will get injected into the duct system and seal all leaks 5/8" and smaller. Efficiency and comfort will be gained by sealing leaks in supply duct allowing more air to reach intended areas and dust will be reduced from sealing return duct stopping them from pulling dust from attics and floor and wall cavities.
2. Seal air leakage into attic by foaming top of all partitions, electrical boxes, duct boots and any soffit. After air-sealing is complete install R-49 of blown cellulose.

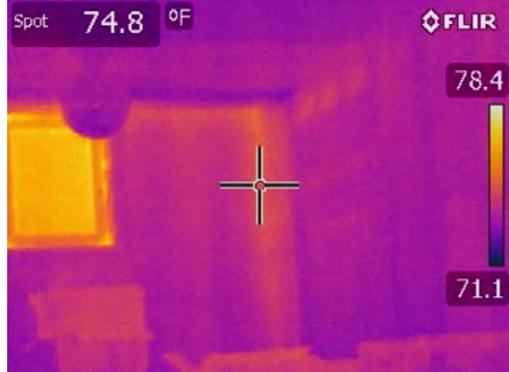
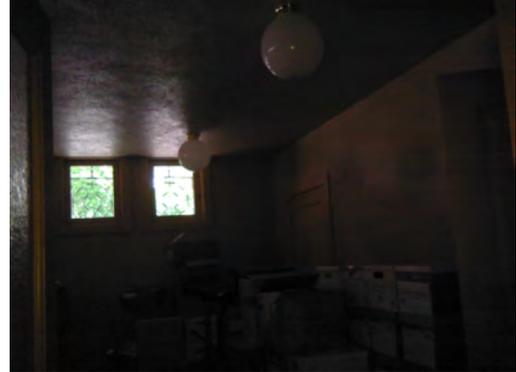
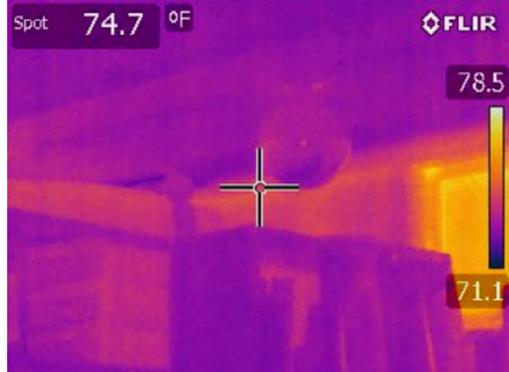
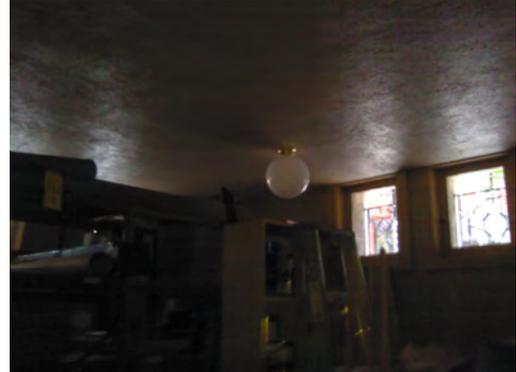
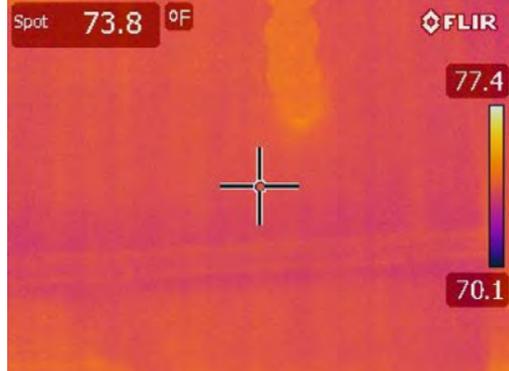
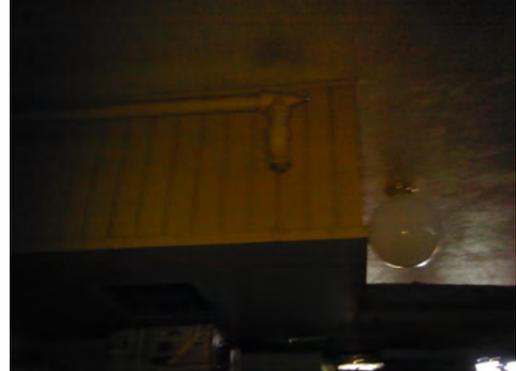
We also found evidence of the air ducts leaking into the building attic and cavities. Excessive duct leakage can severely impact the performance of the buildings HVAC systems. Duct leakage can result in a loss of total system capacity; and potentially causing heating, cooling, humidity and dust issues. These pictures show evidence of cold air leaking into wall cavities where ducts are located and warm attic air entering through registers.
